Report from the Division for Investigation of Maritime Accidents.

## Report regarding the collision between the fishingvessel **SIMONE** and the containership **AURORA** in the Sound on 29 October 2009.

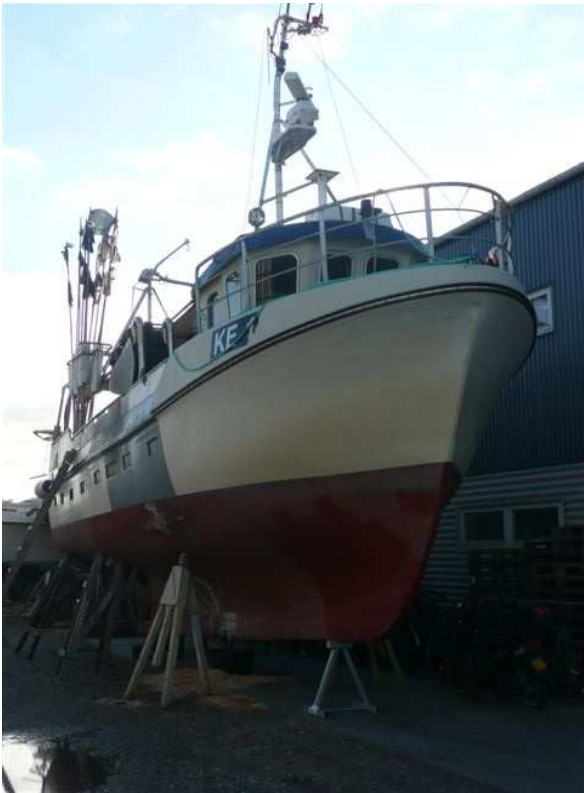
SIMONE (Foto: Opklaringsenheden)

The skipper was not injured by the collision, and SIMONE could return to Fiskerihavnen under its own power. On board SIMONE the collision caused a leak in a diesel oil tank, causing diesel oil to flow into the engine room. When alongside in Fiskerihavnen after the collision a leak in the cargo compartment was discovered. With a borrowed pump it was possible to empty the compartment, and the vessel's own pump was then able to keep the compartment dry.

The Division for Investigation of Maritime Accidents recommends that the owner of SIMONE considers installing an Automatic Identification System (AIS).

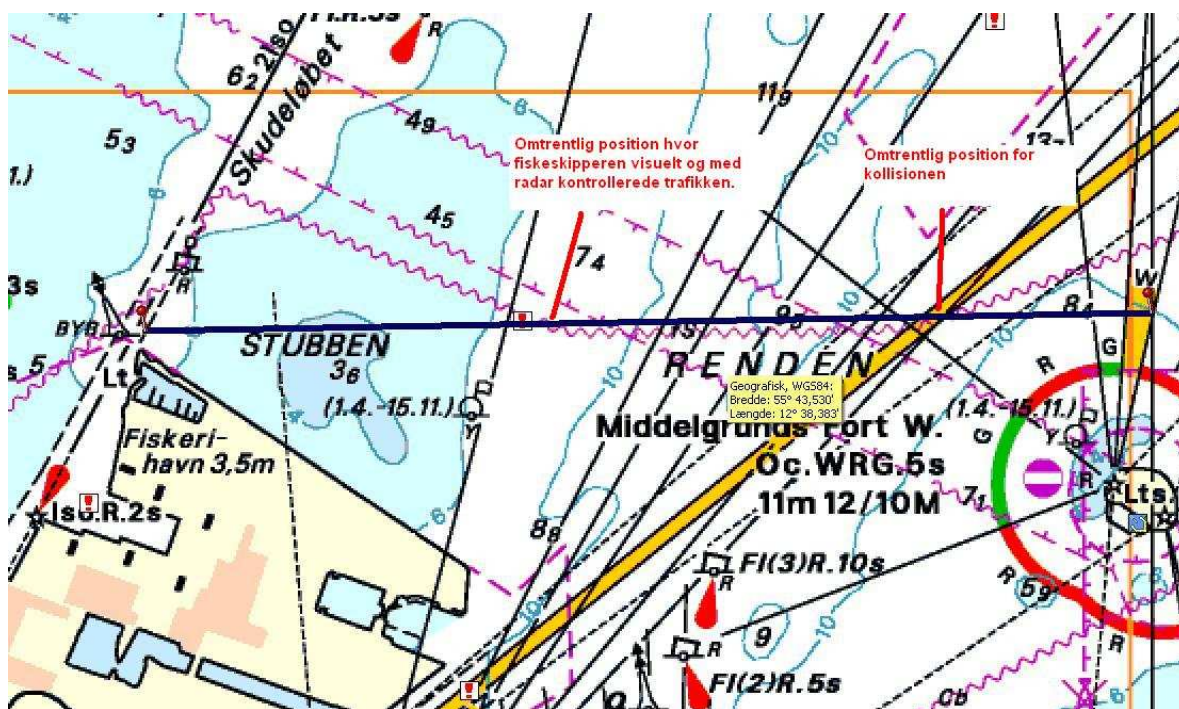
SIMONE departed from Fiskerihavnen in the northernmost part of the port of Copenhagen on 29 October 2009 at approximately 05.55 in order to inspect nets just North of Flakfortet (see Figure 1 – Map extract of SIMONE's route). Immediately after passing the breakwater, the course was changed to East in order to pass North of Middelgrundsfortet, and then direct to the position of the nets North of Flakfortet. Before departure the Skipper checked that the running lights were in working order. Apart from Sidelights, masthead light and sternlight, SIMONE's decklighting was also switched on in order to improve the chance of being observed from other vessels.

Figur 1: SIMONE's route from Fiskerihavnen.

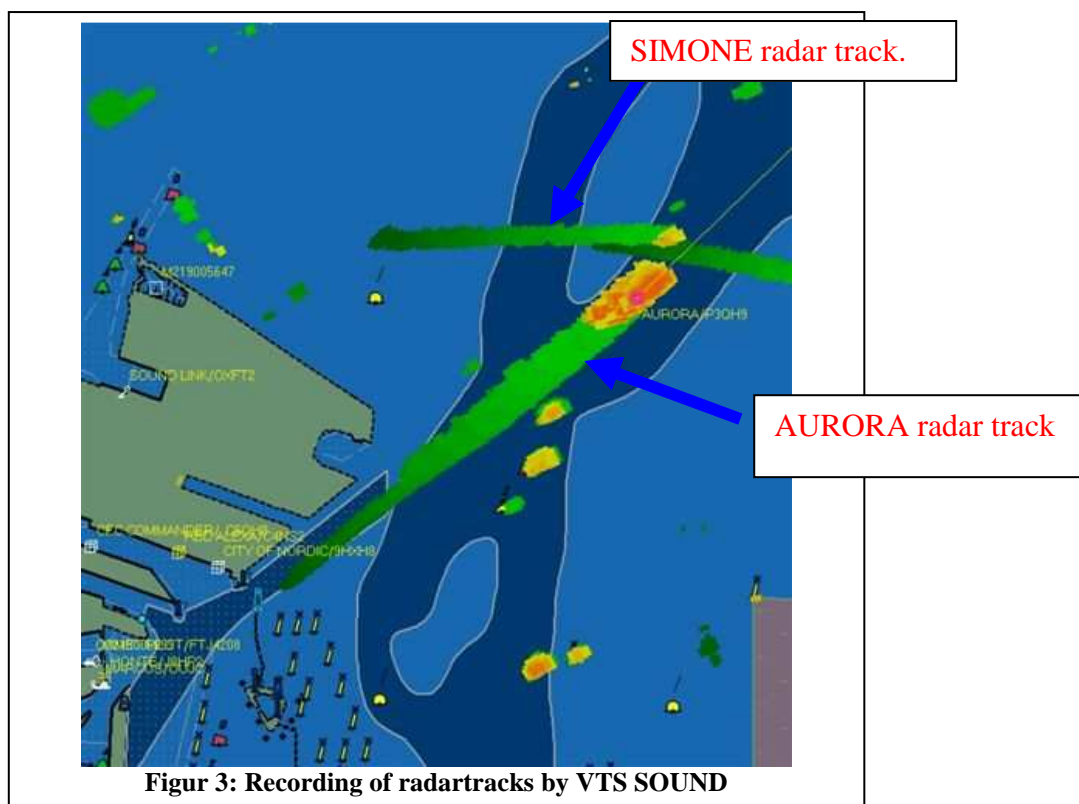
Routinely VTS SOUND recorded radartracks in the area covered by the VTS system. An extract of this recording from the seconds before the collision is seen in figure 3. The 'trails' shown (the green 'wake' behind the radarecho) originates at approximately the time when SIMONE was first observed by AURORA. From the recorded radartrack, it is seen that in the minutes prior to the collision, SIMONE is on a constant easterly heading.
