Division for Investigation of Maritime Accidents - Denmark

Accident to seafarer – DARWIN – 19 August 2009

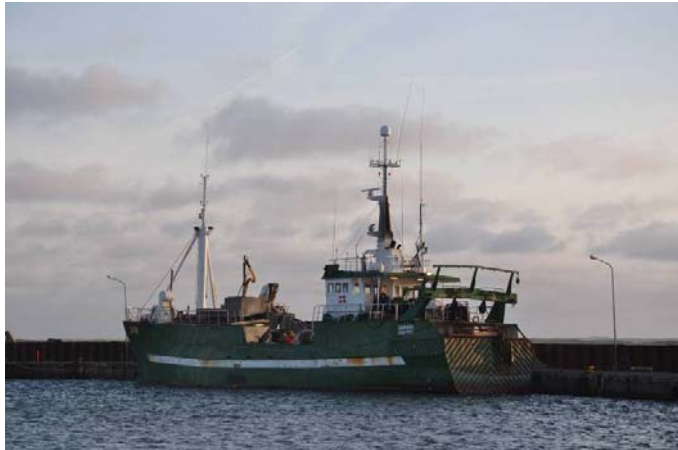
Darwin is equipped with RSW-tanks for storage of the catch. During navigation to the fishing grounds the crew was preparing for fishery. Amongst other things some of the RSW-tanks were to be cleaned. The leading seaman went forward to carry out this task. When he did not return as expected a crew member went forward to fetch him. The crew member found the leading seaman lying unconscious/immobile at the bottom of one of the tanks.

There were no witnesses to the accident. It is in every probability plausible that the leading seaman died due to the injuries he was subject to when he crawled up the ladder to exit the tank. The seaman was not using any kind of fall arrest systems.

- Loss of grip and/or foothold when leaving the tank.

That the owner draws up work risk assessments for any work in the tanks and the access to the tanks.

That the owner takes initiative to enhance the safety culture on board in order to ensure that precautionary measures are performed as prescribed.
