Report from the Division for Investigation of Maritime Accidents

## Occupational Accident on ANN ROUSING on 28 August 2008.

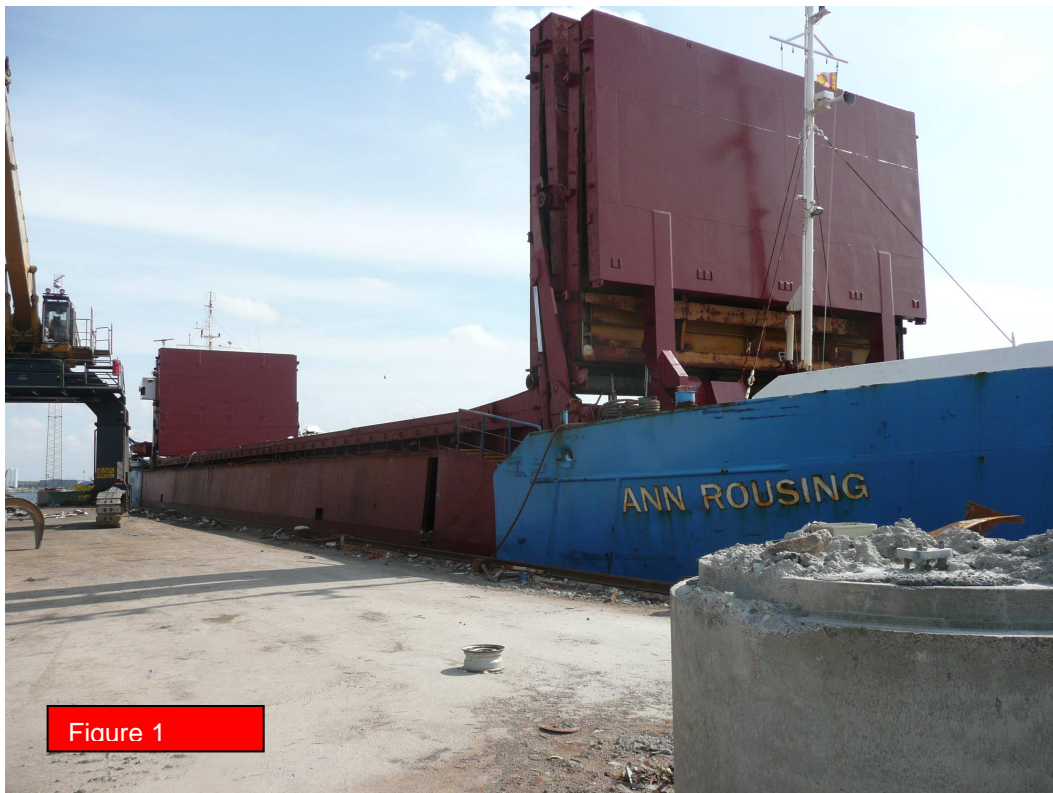
ANN ROUSING (c/s OYIP2, IMO 9037903) is a general cargo vessel. The vessel has one large boxed cargo hold. The cargo hatch is a two-piece folding hatch. One piece folding forward and the other one aft (see figure 1). The vessel is built in 1991 and measures 2326 GT / 2752 TDW. Length overall is 84.90 m, breadth 12.92 m and maximum draught 4.44 m. The vessel is registered in the Danish International Ships register, DIS

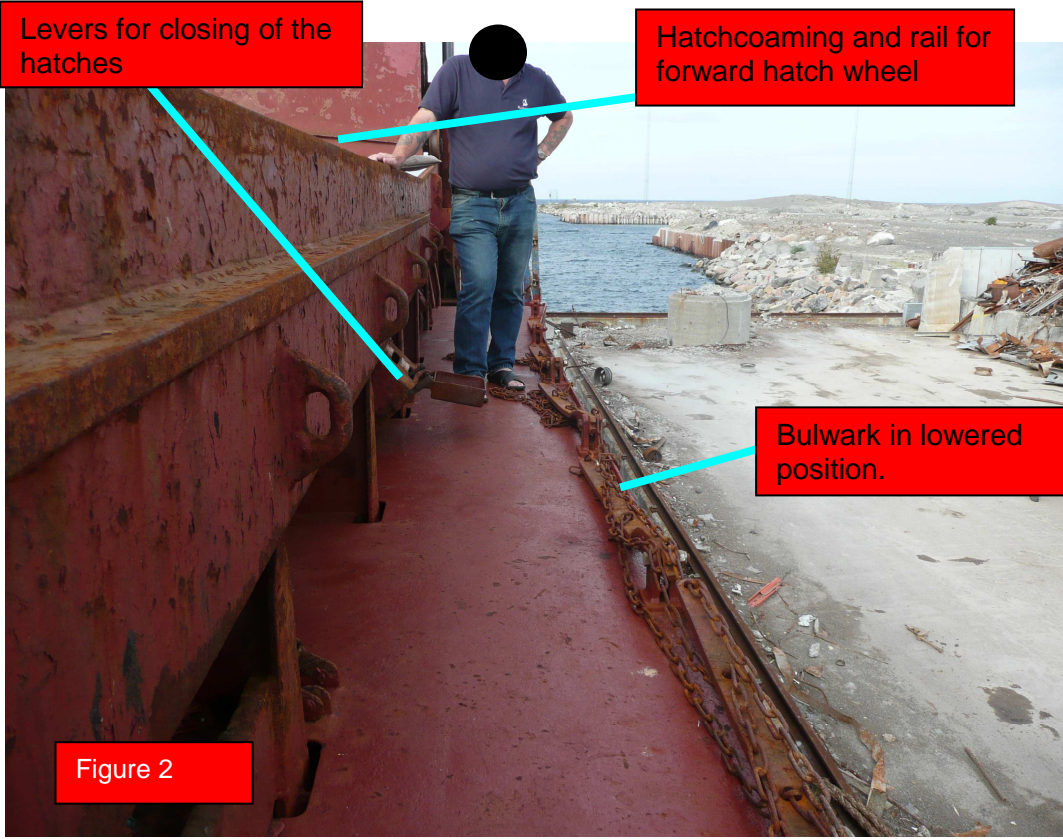
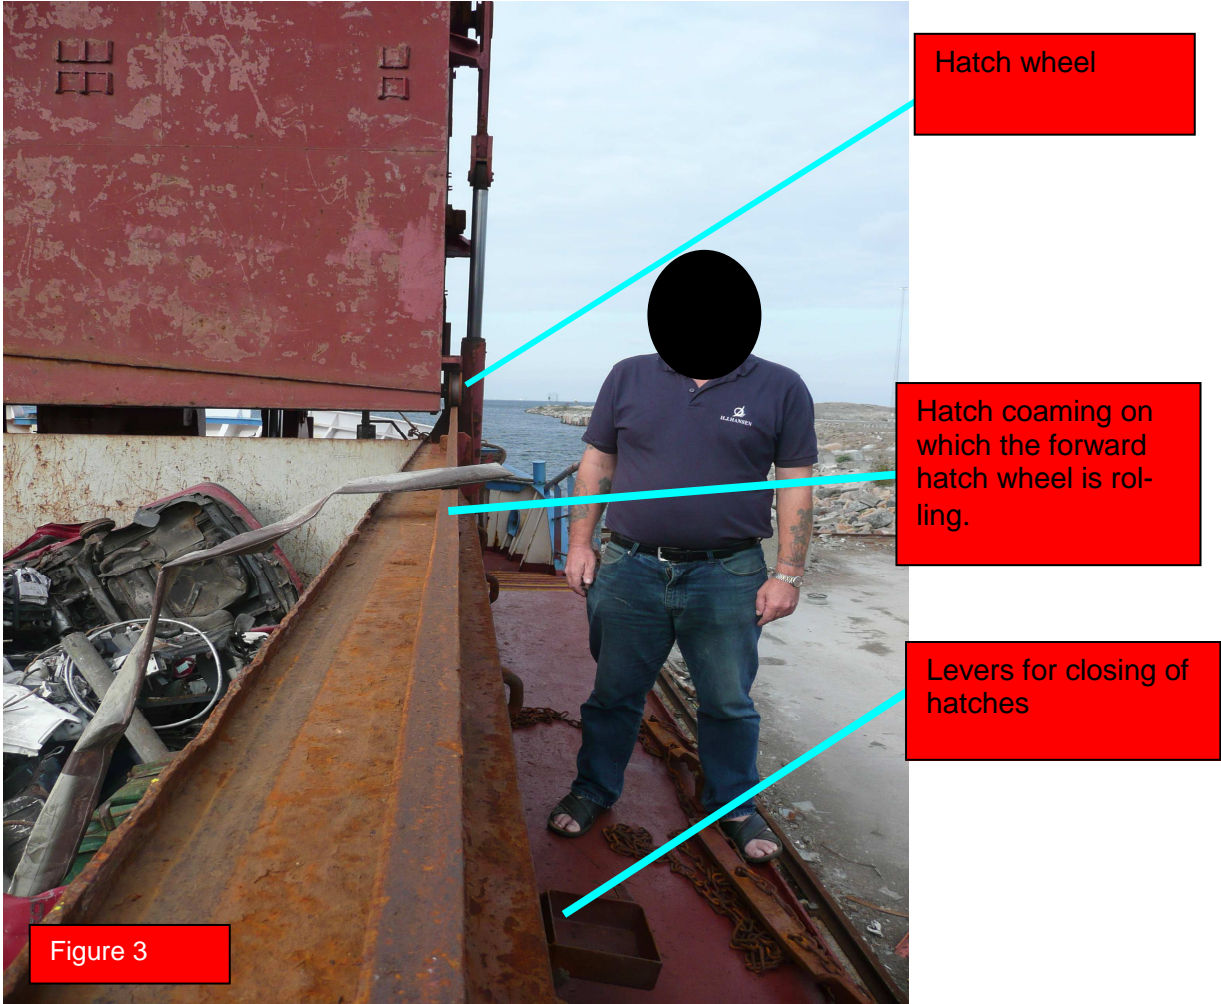
The hatch coaming and the rail on which the hatch wheels are rolling (figures 2 and 3 below) are approximately 1 (one) meter above deck level. The levers for the opening and closing of the hatches are positioned in a box approximately 30-40 cm above the deck.

If the operator let go of the lever during operation, the lever will automatically return to its neutral position, and the hatch will stop and remain in its actual position. There have been no recent malfunctions or repairs on the hatch system or related hydraulics. Following the accident, when operating the hatches, no changes to its normal operation has been noted.

- The injured OS had placed his right hand on the hatch coaming for support while standing on one foot operating the lever with the other.
- The position of the lever operating the hatch was inappropriate, because it allowed the operator to put a hand on the hatch coaming while closing the hatch.
- Written work place instruction was not followed. According to the instruction, a crewmember should have been standing by at the emergency stop.
- There was not sufficient control ensuring that written work place instruction was followed.

- The Investigation Division recommends that the ship owner changes the position of the levers operating the hatches to ensure that it is not possible to put a hand on the hatch coaming while operating the hatches. Alternatively installs screening arrangements at all controlstations for operating the hatches, ensuring that the operator can not operate the levers and at the same time reach the hatch coaming with a hand.
- The investigation division recommends that the shipowner revises the checklist "Task Introduction – Deck Crew" by adding the item 'working environment / workplace instructions', thus ensuring that new crewmembers are introduced to this system and its use.
