CASUALTY REPORT

Case 199921716

Occupational accident

CEC FORCE

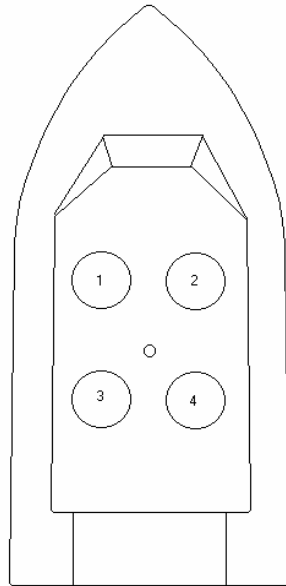
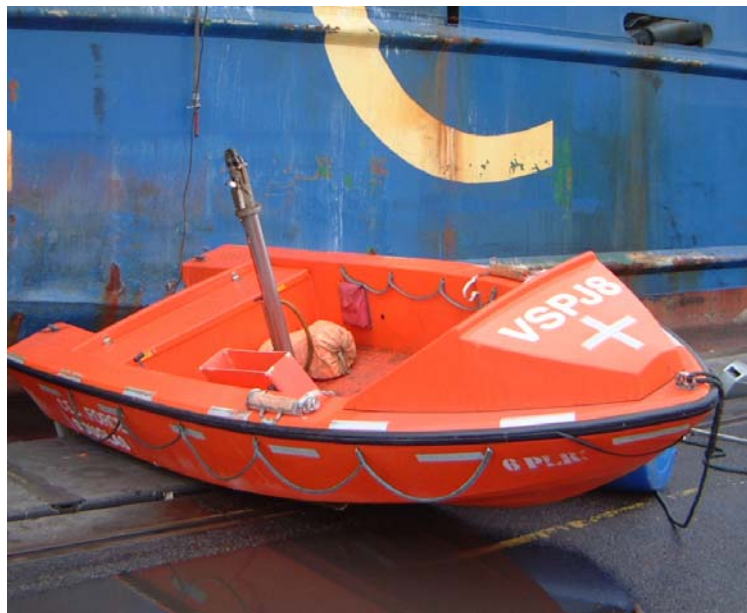
Consequently the MOB-boat was not secured in its cradle neither by lashings nor by hooking on. It fell out of its cradle because it came out of balance by the water being filled into the plastic barrels. And probably also because the worker was moving in the boat while he was filling water into the barrels.

The MOB-boat on the quay after the accident

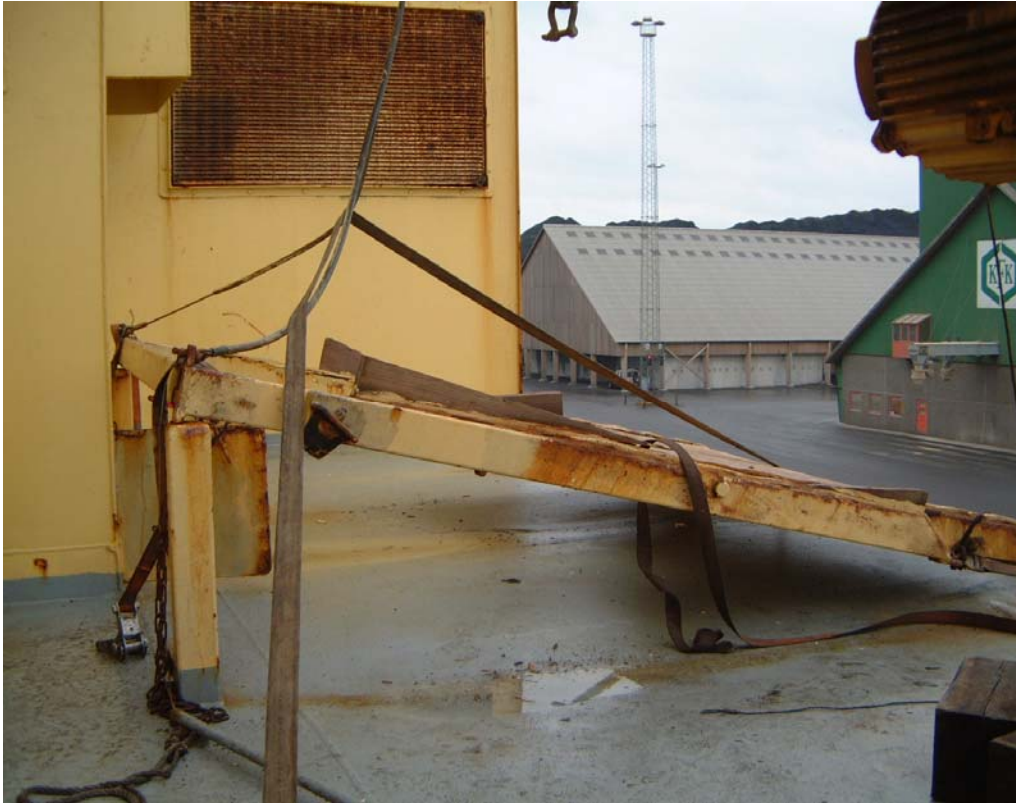
The cradle consists of two sets of legs, each set assembled by a bolted joint that can be folded and unfolded like scissors. When taking off the lashings from the boat one leg in each end of the cradle will be loosened and both legs can be put in line. Thus the cradle will be like a pair of skids and the boat can be launched directly over the ship's side (see pictures in chapter 10).

The technical superintendent and the involved employees from PS Aarhus Flydedok A/S have stated that they did not know about the cradle acting as a pair of skids when the lashings were taken off. They had seen the cradle as a fixed cradle and nobody had noticed that the cradle's legs could be opened and folded as described.

The cradle folded

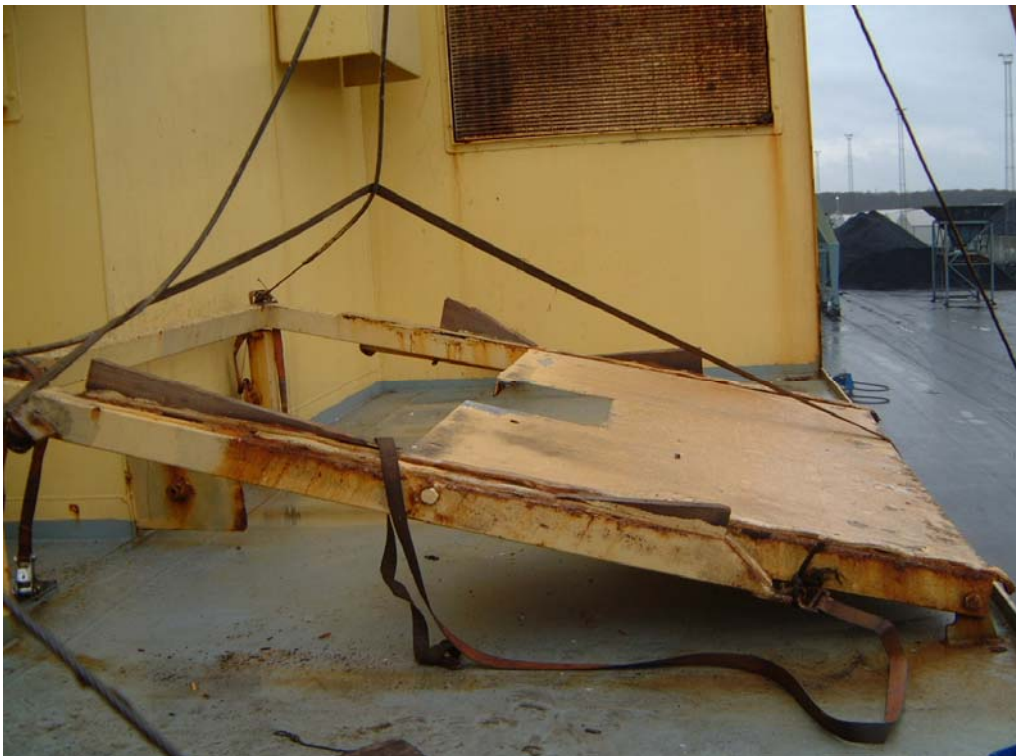
The cradle folded

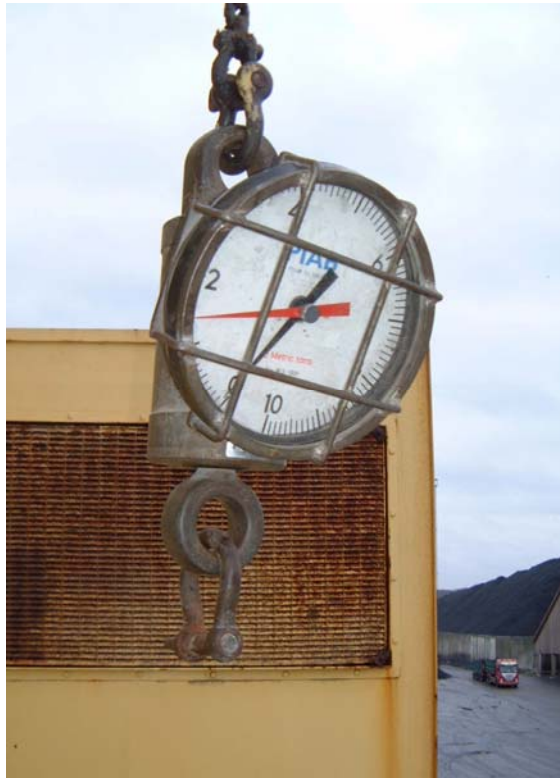
The weight of the boat including equipment was known. The Investigation Division considers that the use of dynamometer was unnecessary and troublesome.

The dynamometer

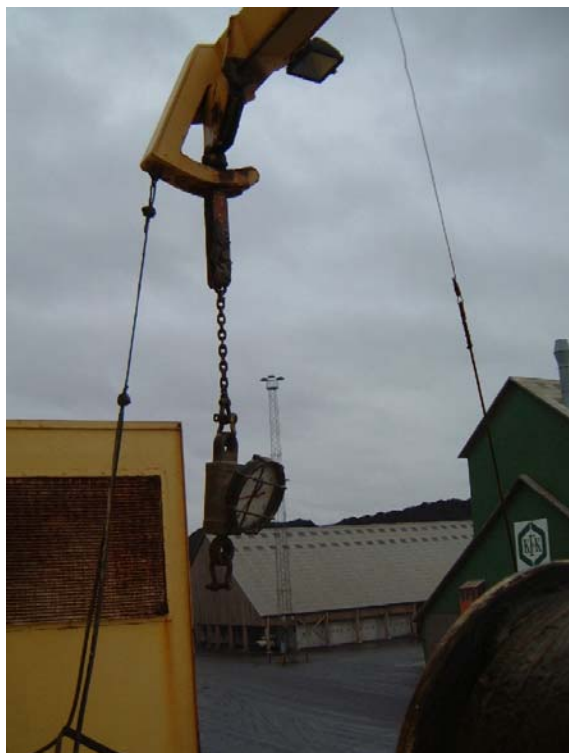
The employees from PS Aarhus Flydedok had shackled on the dynamometer to the short piece of chain (approx. 50 cm) hanging below the wire and its iron bob. Thus the connection between the wire and the boat was extended by the length of the dynamometer and two shackles (approx. 50 cm).

When the dynamometer was mounted to the chain but not hooked on to the release hook that was fixed in the MOB-boat it was obvious that the shackle under the dynamometer was hanging far below the hook, so that the entire connection would become slack when hooking on. This was supposed to be a problem in regards to deploying the boat and the repair engineer called for a rigger to help shortening the connection. However the rigger was busy and hindered in helping on that time. The shackle below the dynamometer was not hooked onto the hook.

The dynamometer mounted to the chain below the iron bob

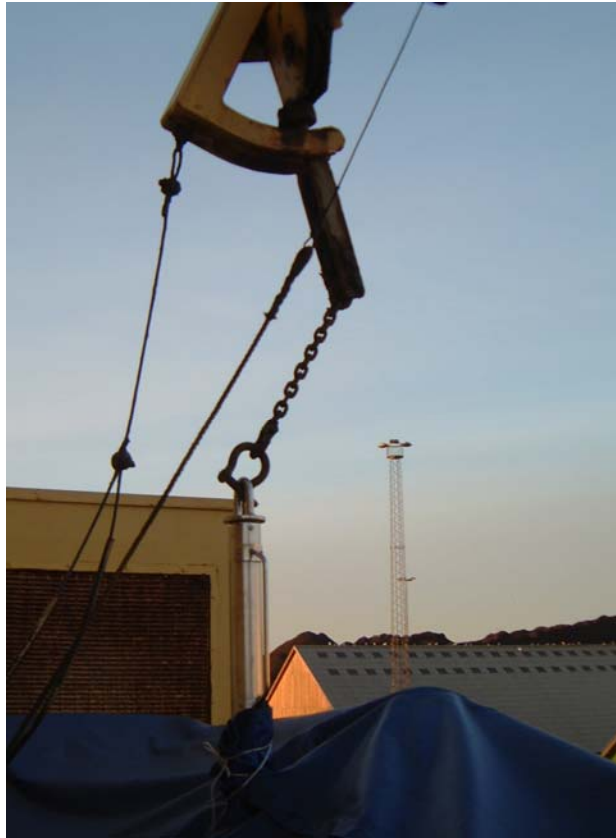
The new MOB-boat hooked on

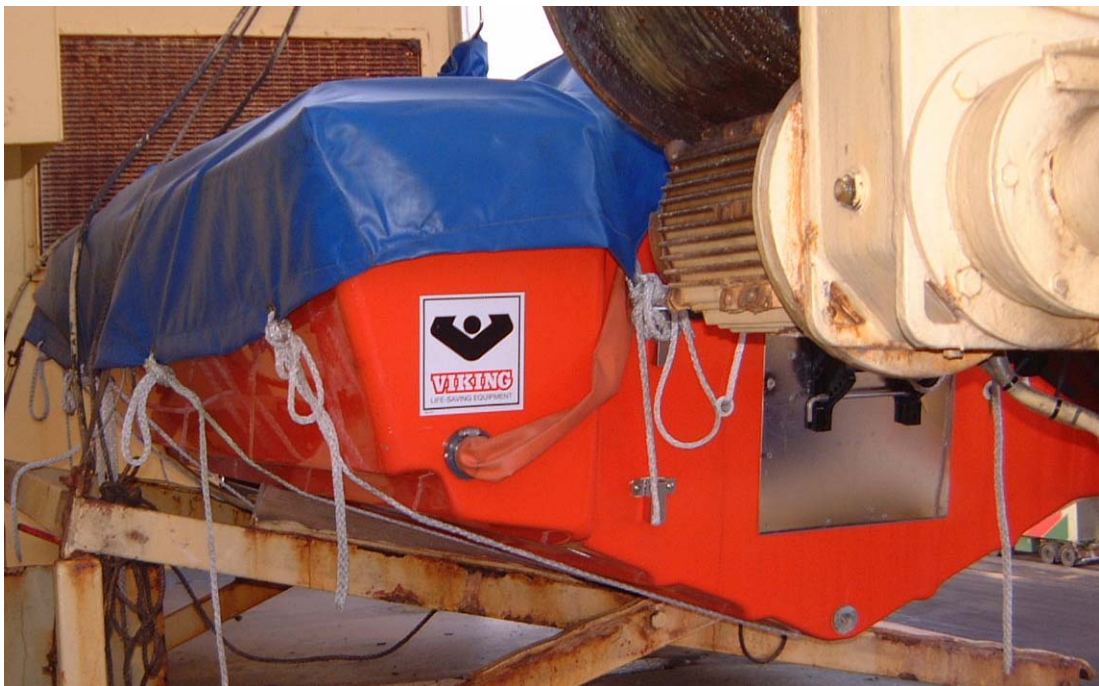
The new MOB-boat in its cradle
