## Division for Investigation of Maritime Accidents - Denmark

### Occupational accident on KALUNDBORG SUPPLY on 18 March 2007

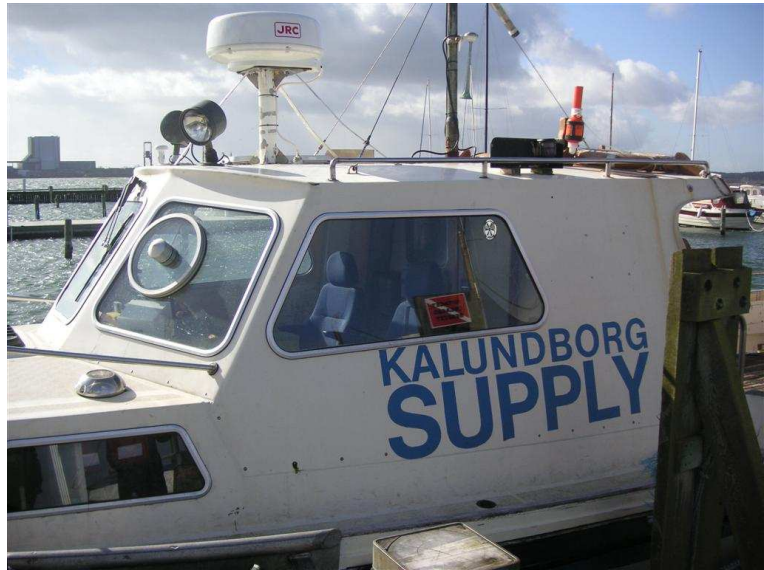
There was a strong breeze and the tanker had turned to give lee for KALUNDBORG SUPPLY. When KALUNDBORG SUPPLY was going alongside the tanker the crew member stepped upon the covering board on port side to fetch some luggage that was being handed to him from the tanker.

Just as the crew member had received a bag and intended to go abaft, the vessel moved heavily in the sea and the crew member lost his hold on a hand rail and fell overboard.

- The vessel was designed inappropriately as regards transferring personnel and gear via the covering board and the fore deck. The covering board and the fore deck were risky to walk and work on at open sea.

- The crew member was on the covering board beside the wheel house as he with one hand held on the hand rail on the top of the deckhouse and with the other hand received a heavy bag that was handed to him.
