Marine Accident Report

DUCHESS of
SCANDINAVIA
Occupational accident
on 11 August 2005

The casualty report has been issued on 17 February 2006

Case: 200508990

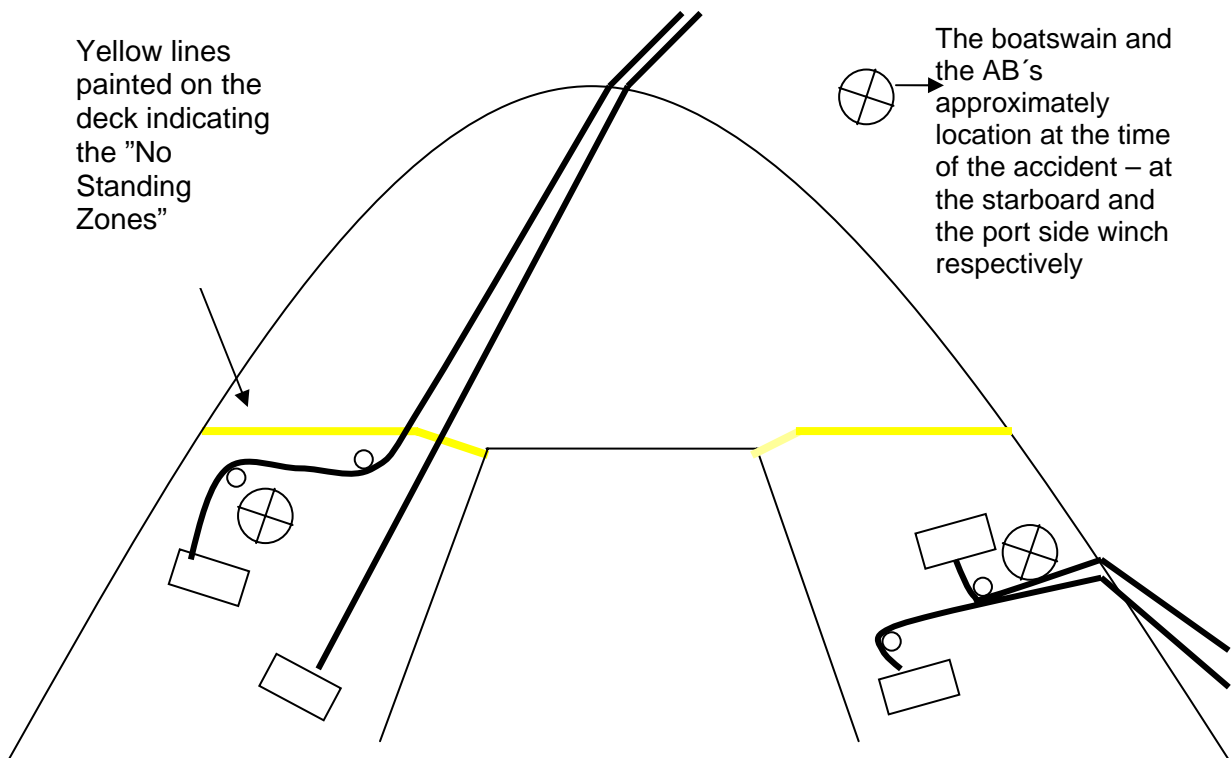
Sketch of the mooring arrangement on the forecastle – see also the picture under section 3.7 According to the boatswain, the yellow lines indicates the area on the deck where the crew must be placed (forward of the lines) when the winches are operated and when there is no visual contact with the winch operator.

There was no visual contact between the boatswain and the injured AB from where they were standing respectively when the accident occurred – see sketch on page 7.

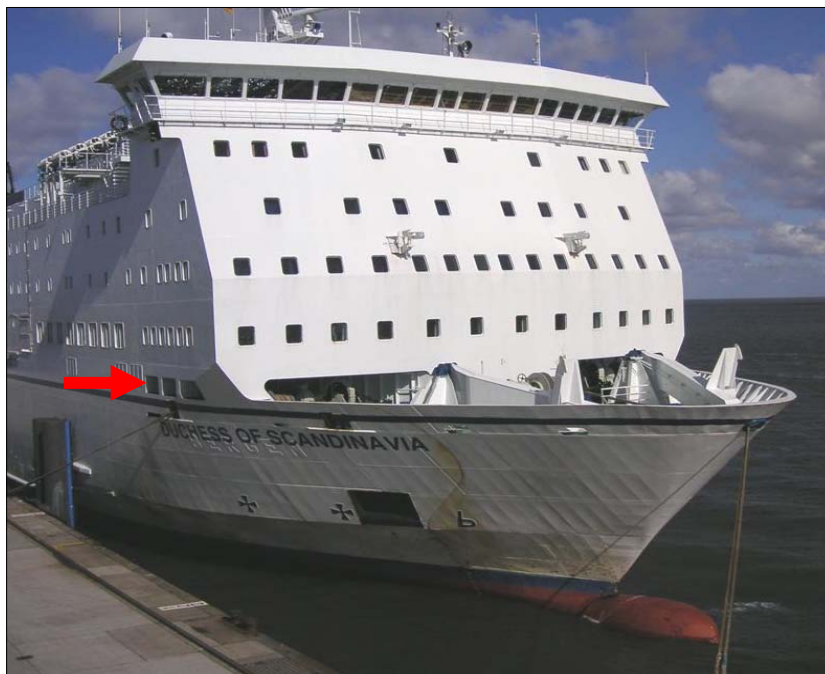
Photo: The ship alongside the port of Cuxhaven on 16 September 2005 – moored as on the day of the accident with two relatively short hawsers and two small spring lines.

The winch operator can see all of the hawsers ashore through the marked openings (see mark on the picture above). However, it is not possible to see the winches in the opposite side from this position.

The deck's arrangement impedes a full view to the winches from an angle where also the hawsers ashore can be seen.

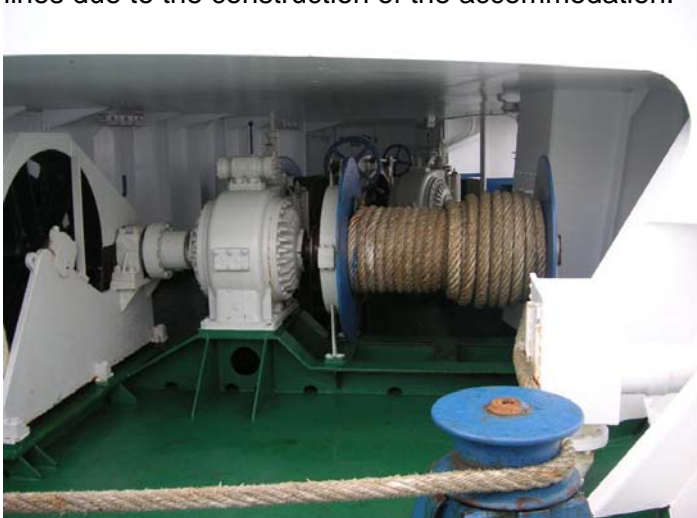
Photo: Photo taken on 14 September 2005. Forward winch port side.

The picture above was taken while the ship was alongside in the port of Cuxhaven. The guide pulley in the front of the picture has the effect that the hawser has a tendency of spooling upon the outer side of the winch drum.

According to the master, a part of the hawser normally has to be spooled off again after departure in order to straighten it out.

Normally, it is necessary to spool a part of the hawser off again after departure in order to straighten it out.

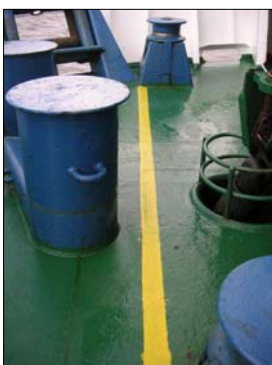
Photo taken on 14 September 2005

The limit for the “No standing Zones” (yellow lines) were initially painted in February 2004 on the recommendation of the deck’s safety group – see details in 3.12 last paragraph.

The yellow lines were repainted after the accident. The deck on the forecastle was painted all over during the summer 2005 which partly had erased the stripes. By mistake, the lines had not been clearly repainted.

According to the information from the chief officer and the boatswain, the stripes were partly visible and therefore not completely erased.

The limit for the "No standing Zones" (yellow lines) were initially painted at the beginning of 2004 on the recommendation of the deck's safety group. However, the instructions about the "No standing Zones" do not appear from the risk assessment.

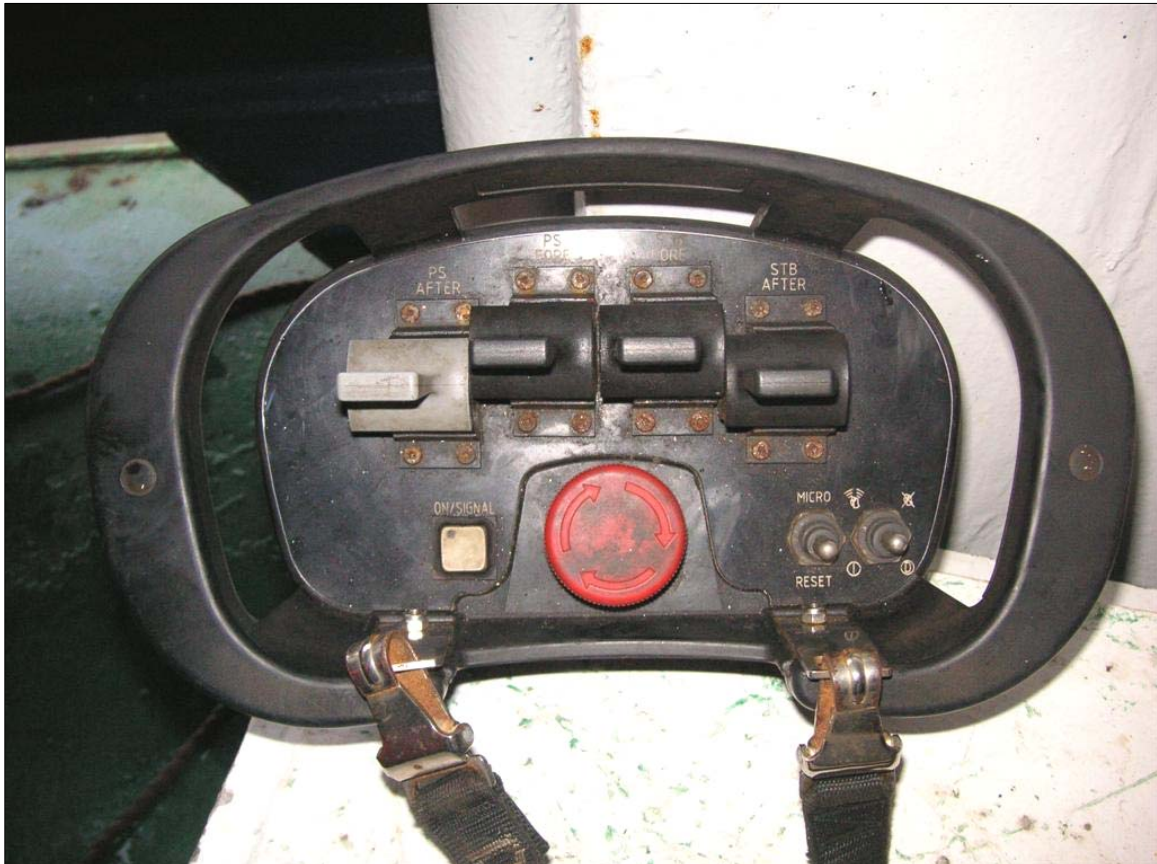
Photo: photo from 14 September 2005. Portable winch control (wireless)

The winch control on the photo is carried in a brace-end around the neck so that the operator has both hands free.

The four upper switches operate the winches. When the hawser is placed normally on the winch drum, as in this case, the hawser is eased off when pushing the switch forward. The switches automatically go to neutral position and the winch stops when not activated.

The Division for Investigation of Maritime Accidents recommends DFDS and the ship's safety organisations to reconsider the safety instructions for the use of remote controlled winch controls.
