**DANISH MARITIME AUTHORITY**

**ESTELLE MÆRSK  
Accident to seafarers on 30 October 2009**

## **The casualty report has been issued on 22 February 2010**

**Case:** 200913680

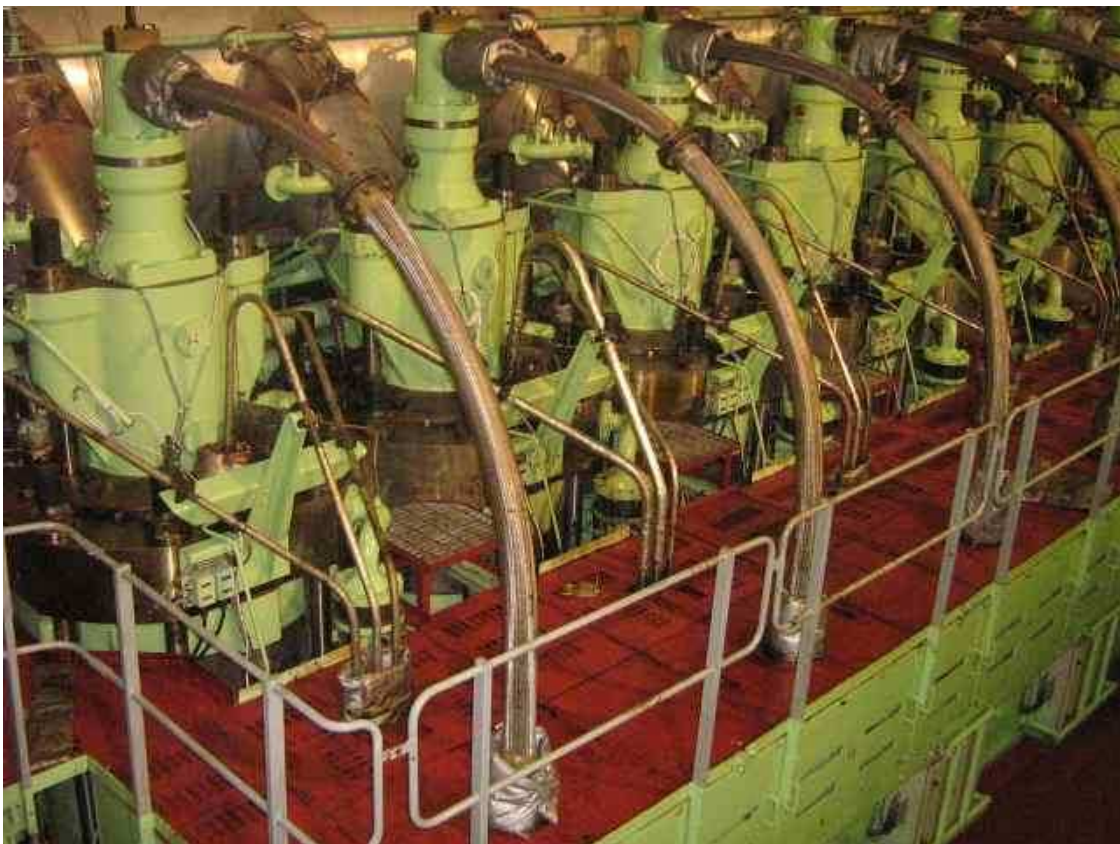
Upper platform of the main engine

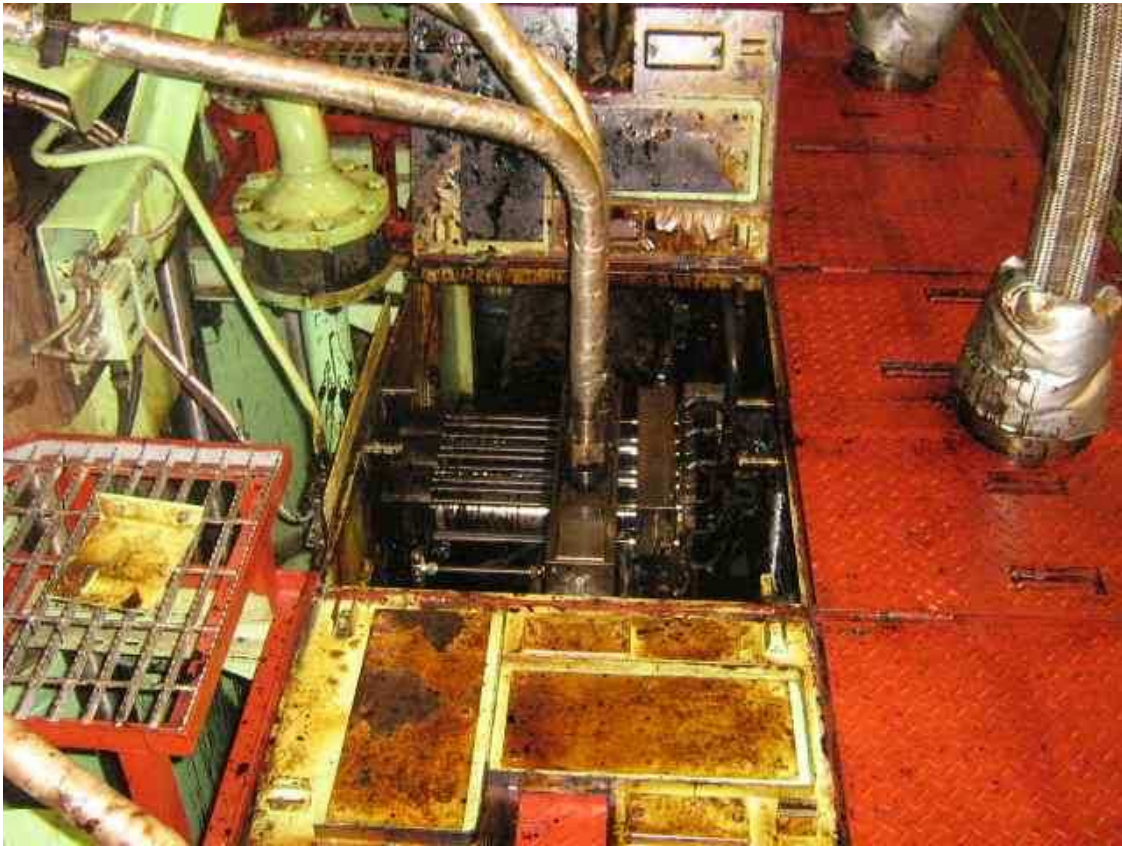
The ICU situated on the fuel oil rail

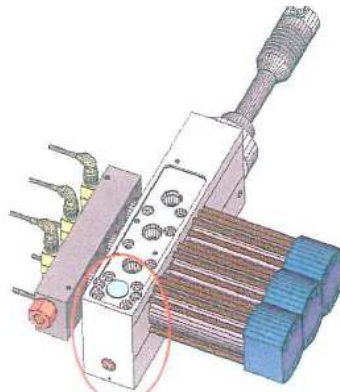
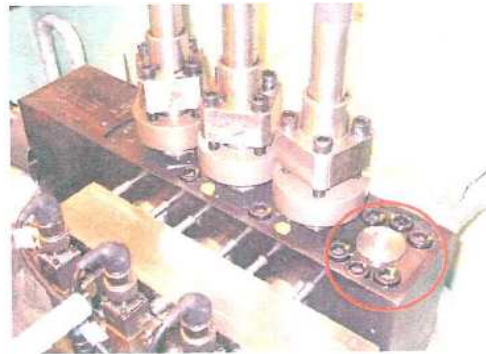
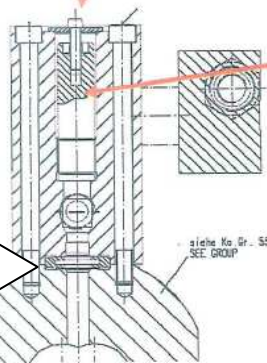
Rag was stuffed here

The Investigation Division considers that stuffing a rag into the bore made it possible to build up a pressure inside the fuel oil rail.

The Investigation Division considers that the continued heating of the fuel oil rail is likely to have caused a pressure build-up inside the rail due to gasification of fuel oil constituents.
