Report from the Division for Investigation of Maritime Accidents

FINOLA

Mooring Accident

4 January 2007

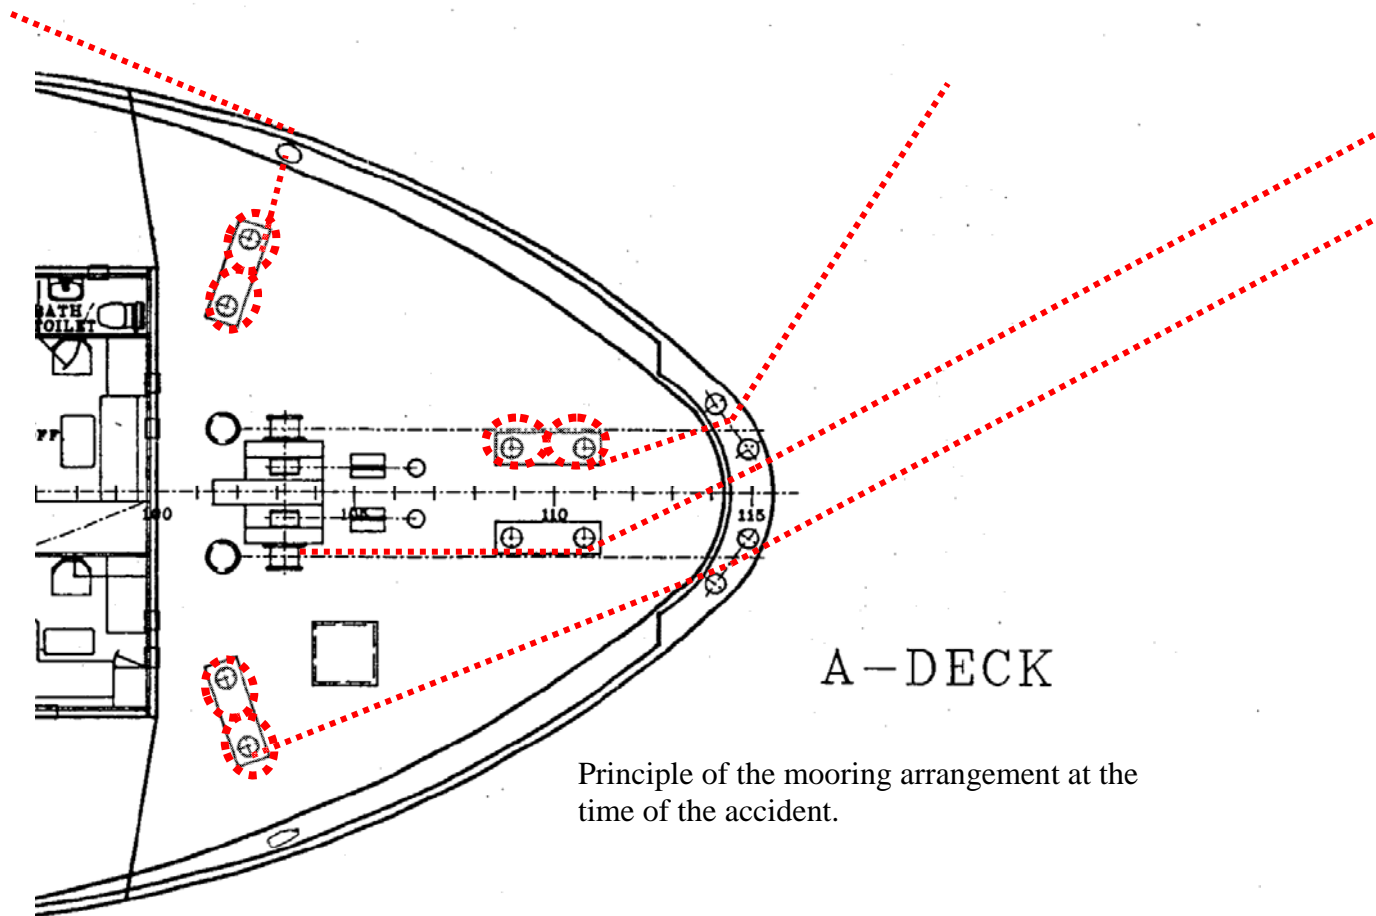
From the forecastle the vessel was moored with one long spring line and three fore lines - one short and two long fore lines. All lines were hawser-laid ropes and they were made fast on pollards on board – see *the sketch of the mooring rearrangement in the appendix*.

The second officer took over the watch at about 1200 hours as usual. Two hours later - at about 1400 hours - two of the lines forward snapped due to the increasing swell. The master, who was at the bridge at that time, saw what happened and he called the 2nd officer by his portable vhf.

According to the 2nd officer they were about to secure the last fore line when a swell suddenly lifted the ship. The AB had put on the "stopper" on the line and the 2nd officer was then easing out the line by the mooring winch.

Due to the sudden pull on the line, the AB was not able to hold the line by the "stopper" and line laid around the winch drum was tightened and hit the 2nd officer on his arm. It all happened very fast.

Principle of the mooring arrangement at the time of the accident.
