**MARINE ACCIDENT REPORT  
DIVISION FOR INVESTIGATION OF MARITIME ACCIDENTS**

**MINA  
Occupational accident  
on 27 February 2006**

## **The casualty report has been issued on 14 November 2006**

**Case:** 200602366

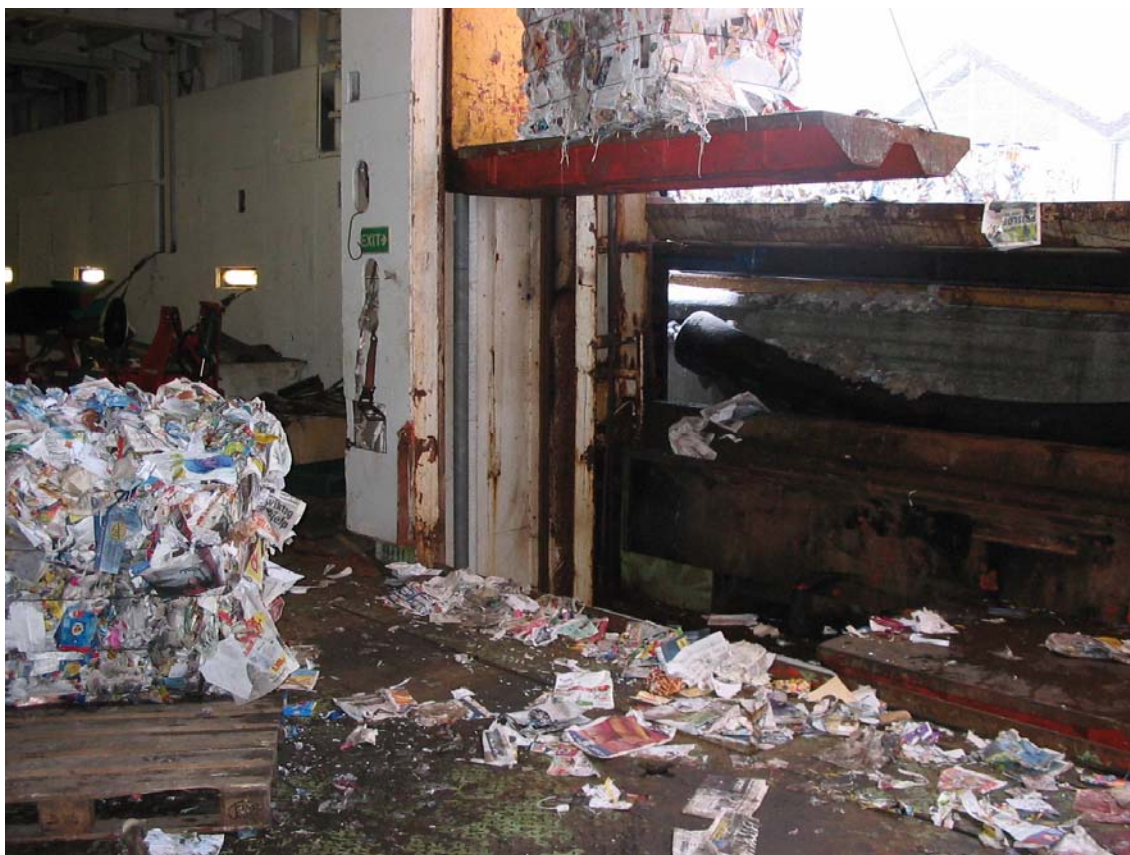
During the loading in Sandnes, Norway, of paper bales to the tween-deck by the ship's elevators, one paper bale, weighing about 500 kg, tipped off the elevator and fell approximately 4 meters to the deck, where it hit an ordinary seaman, OS, who passed by the elevator.

*Picture by the harbour authority, taken shortly after the accident*

According to the mate and also according to the report by the Norwegian police the area was not marked at the time of the accident. (*See the picture on page 4*).

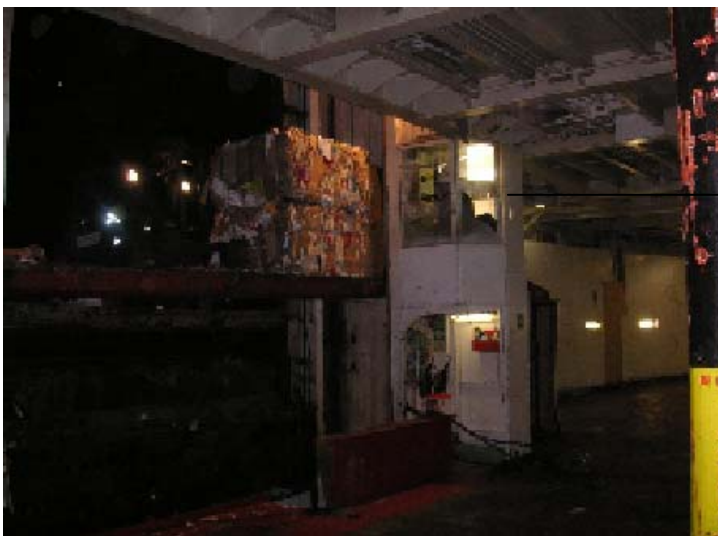
Operators cubicle

The elevators can be operated from an operator desk placed in a cubicle above and forward of the hatch and from where there is an overlook to the elevators and the tween-deck. The elevators can also be operated by remote control boxes hanging on the forward side of the hatch or used free through connecting cables.

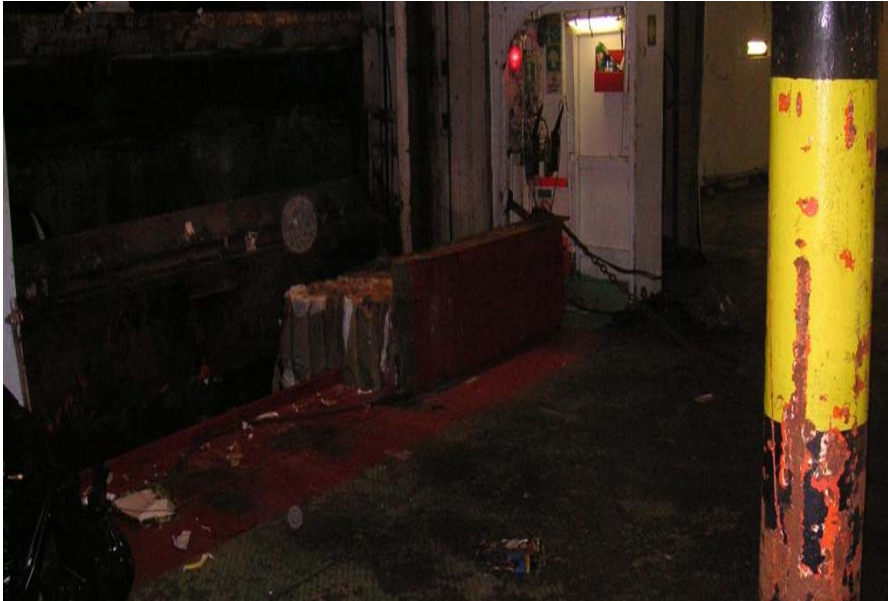
The accident happened on the tween-deck in the area close to the hatch and the elevators. An area of the deck along the hatch and the elevators, approximately ½ meter wide, is considered "dangerous area" according to the crews statements.

At the time of the Investigation Division's visit the area was painted red.
