CASUALTY REPORT

NICOLAI MAERSK

Drop of lifeboat

13 February, 2001

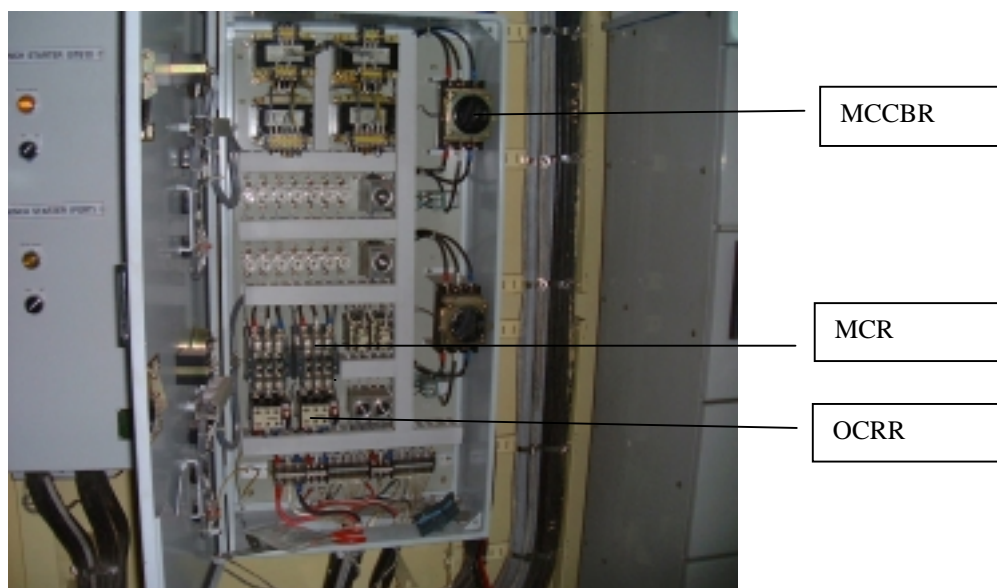
In the Electrical Panel Board located in the HI-press room are 2 identical circuits for the starboard and port winch motor. The main modules in the electrical circuit (see ANNEX 2) are:

The Main Circuit Breaker (MCCBR), which protects the electrical circuit and power source from any malfunction during the operation of the winch motor which may result in excessive amperage in the electrical circuit.

The Main Contactor Relay (MCR), which controls the on/off function of the winch motor and the remote control box at the boat deck.

The Over Current Control Relay (OCRR), which controls any overload during the operation. When activated this cuts power to main contactor relay (MCR).

that it was possible to operate the winch motor from the Electrical Panel Board by resetting the OCRR, then push the black button on the MCR and then reset the MCCBR,

that by manual pushing the MCR button the function of the MCCBR is cut out, however, the motor can still be stopped by pushing the Emergency Stop button at the remote control box,

that by manual pressing the MCR button the function of the Proximity Switches at the david is cut off,

that according to the electrician he was only pushing one of the buttons of the MCR, which means that not all 3 contacts make contact at the same time, which again can explain a high current consumption and the fact that the MCCBR was tripped off several times and that the winch was running in jerks at the beginning.
