Report from the Division for Investigation of Maritime Accidents

## **Container ship OLUF MÆRSK**

**Accident to seafarer, 5 January 2009,**

## **Crew member injured while handling CO<sub>2</sub>-cylinders**

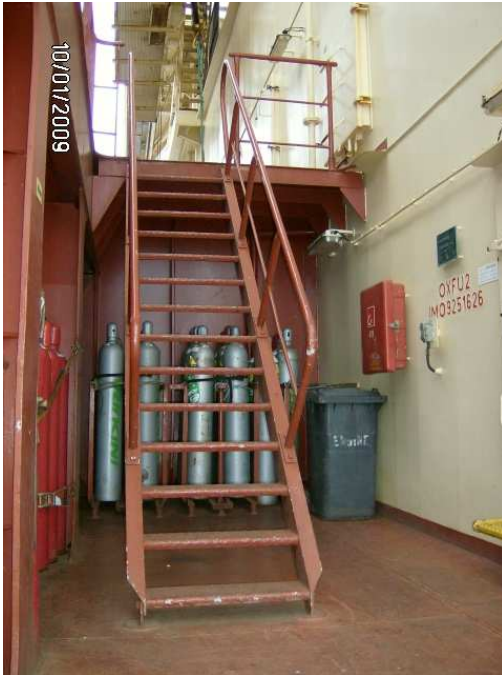
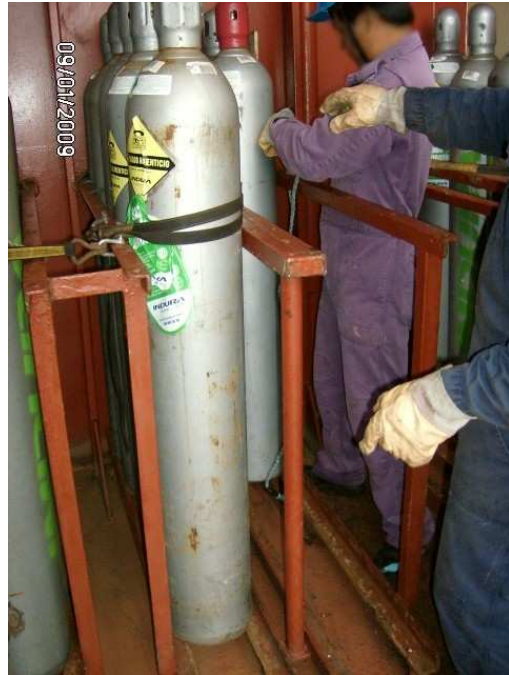
The cylinders' placement on the main deck aft of the accommodation

35 cylinders are placed in transverse racks on the main deck aft of the accommodation on the starboard side as shown on the picture. The rest of the cylinders are to be stowed directly on deck and lashed to the coaming of the aftermost hold.

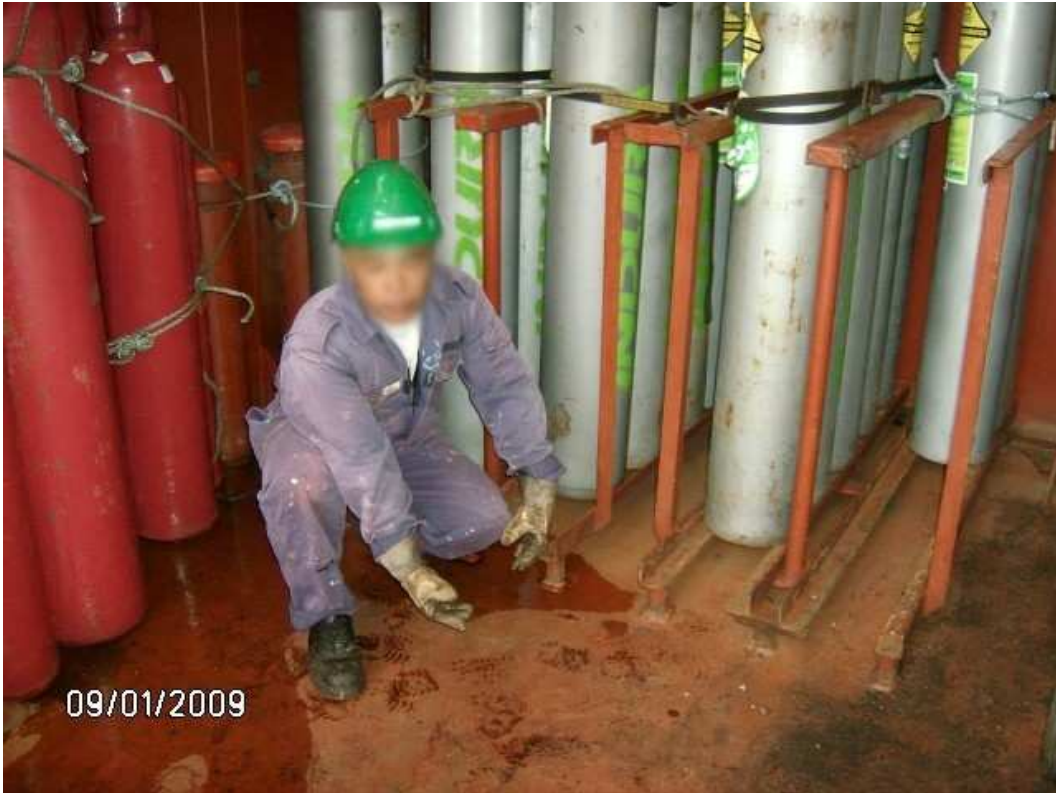
A crew member in the same position as in the situation of the accident

The AB was holding the cylinder on top while the OS was squatting on the deck holding at the bottom helping to push the cylinder to reach the rack lane. Suddenly at 1935, one cylinder already placed in the rack but not yet secured, fell over and hit the OS who was squatting on the deck. He was hit and contused at his head.

A crew member squatting on the deck just beside the cylinder racks is in a very vulnerable situation and rather exposed to be hit by a tilting cylinder.

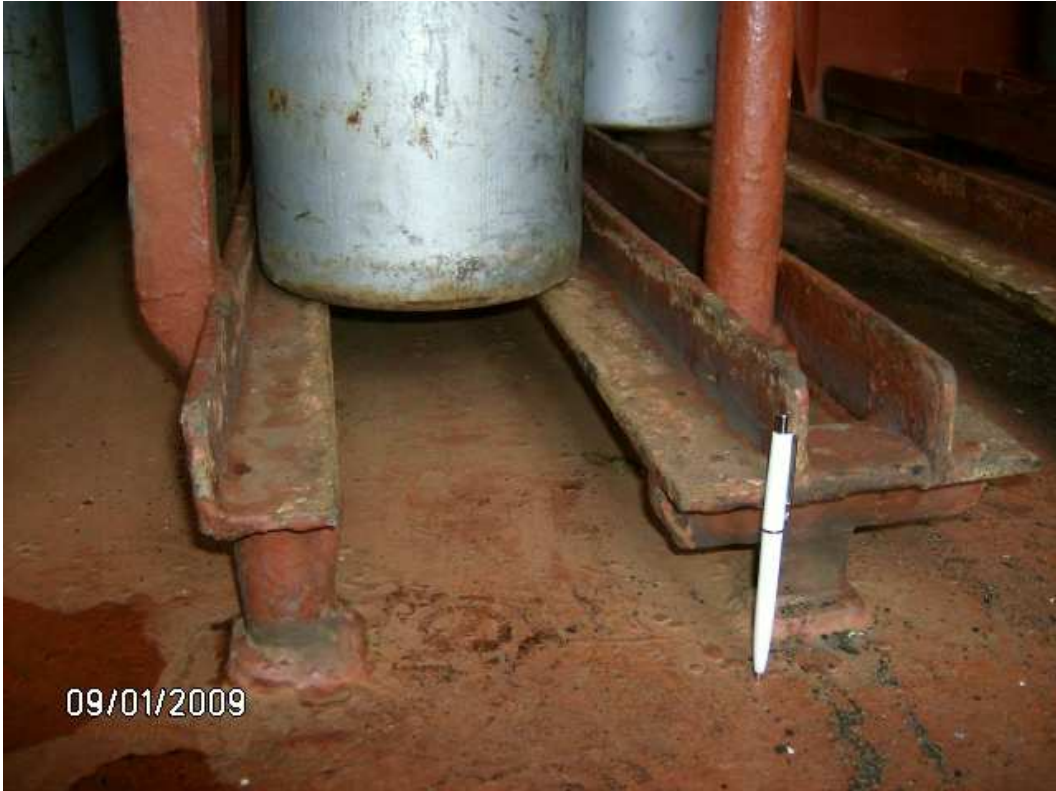
The bottom of CO<sub>2</sub> cylinders, not firmly standing in the racks

At the time of the accident four CO<sub>2</sub> cylinders had already been stowed in the rack but not secured. When standing in the stowage rack the CO<sub>2</sub> cylinders get very little support and can easily tilt, when the vessel is listing during cargo operation.

The rack gave no transverse support to the cylinders if not secured.

When placed in the racks and not yet secured the cylinders could easily tilt because of transverse movements of the ship during loading operations.

The CO<sub>2</sub> cylinder tilted because of movement of the ship and because it was not yet secured.

As an immediate corrective action locking pins were made to be inserted step by step when stowing cylinders in racks.
