# Report from the Division for Investigation of Maritime Accidents

## **VINLAND SAGA – Fall overboard 5 September 2005**

VINLAND SAGA (OZAC2), IMO No. 8126549, homeport Bogense, Denmark, is a 972 GT shelter deck dry cargo ship built in 1982.

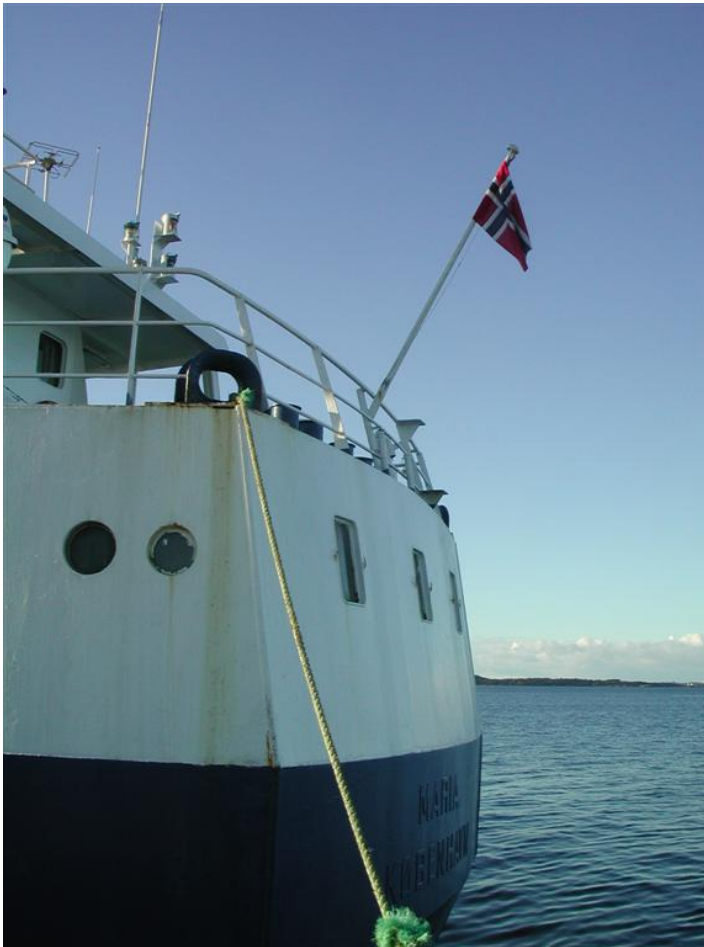
The flagpole was a normal iron pipe, which at the level of the railing was inserted in a slightly wider pipe with flaps, which could be pressed together. Two bolts kept the two pipes together. The pole was painted white and looked new painted. At the top of the pole there was a piece of flat iron with a hole in which the block was shackled. The block that should replace the lost one was a little bigger, and therefore the hole should be widened using a drill.

At a drawing of the ship the Investigation Division has measured the flagpole to approx. 2.8 meters and the top of the pole to be approx. 8 meters above the water level in the actual loading condition.

*Picture of a sister ship of VINLAND SAGA*
