Report from the Division for Investigation of Maritime Accidents

Chemical/Products tanker NORD SNOW QUEEN

Accident to seafarer, 14 January 2009

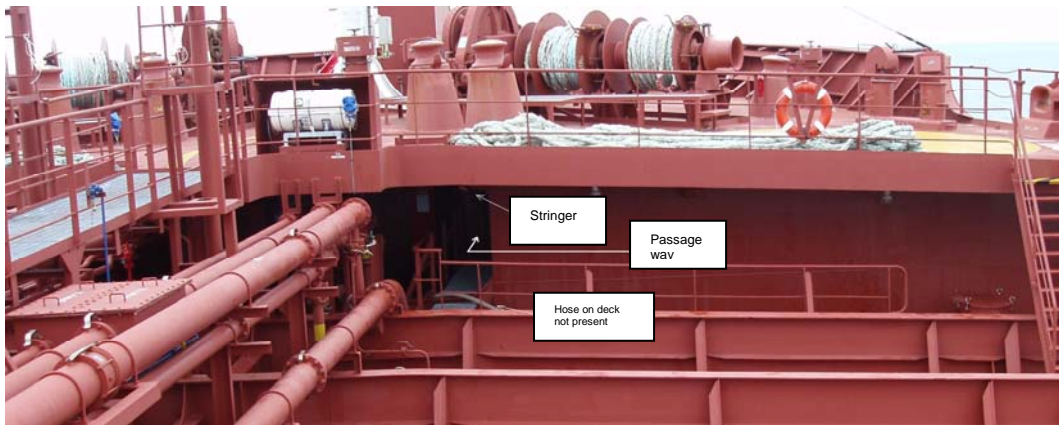
View to the forecastle and the place of the accident

On his way to the paint shop, when passing on a catwalk on the starboard entry below the forecastle, he hit his head against a stringer, and due to the heavy impact he was knocked out and fell down unconscious. He was not wearing a protective helmet.

Where the catwalk is turning from transverse to longitudinal there is a stringer below the forecastle.

The height from the grating to this stringer is 165 cm at the lowest side increasing to 186 cm at the highest side.

The stringer was painted in yellow and black stripes.

The height between the catwalk grating and the upper stringer is 165 cm increasing to 186 cm.

The upper stringer was painted in yellow and black stripes, but not covered by any soft and protective material.

The chief officer hit the upper stringer because this was situated over a catwalk in a relatively low height.

The lower stringer may have drawn the attention of the chief officer passing on the catwalk and thus prevent him from becoming aware of the upper stringer.

Furthermore it was suggested to apply rubber protection pads to sharp corners on low hanging stringers and all yellow markings and yellow/black warning stripes to be renewed where necessary. This conclusion has been distributed to the fleet of sister ships as well as to the site office.

A new railing is planned to be erected on the catwalk near the stringer to slow down persons' passing to the paint shop.

- to emphasize to all seafarers employed by the company the importance of wearing a protective helmet as stated in the company's own instructions and
- to implement considered/planned alterations of the railing arrangement at the catwalk to ensure the safe passage beneath the stringer on this ship and on sister ships as well.
