# Casualty Report

## **Occupational Accident**

### **DITTE THERESA**

**On 7 May 2003**

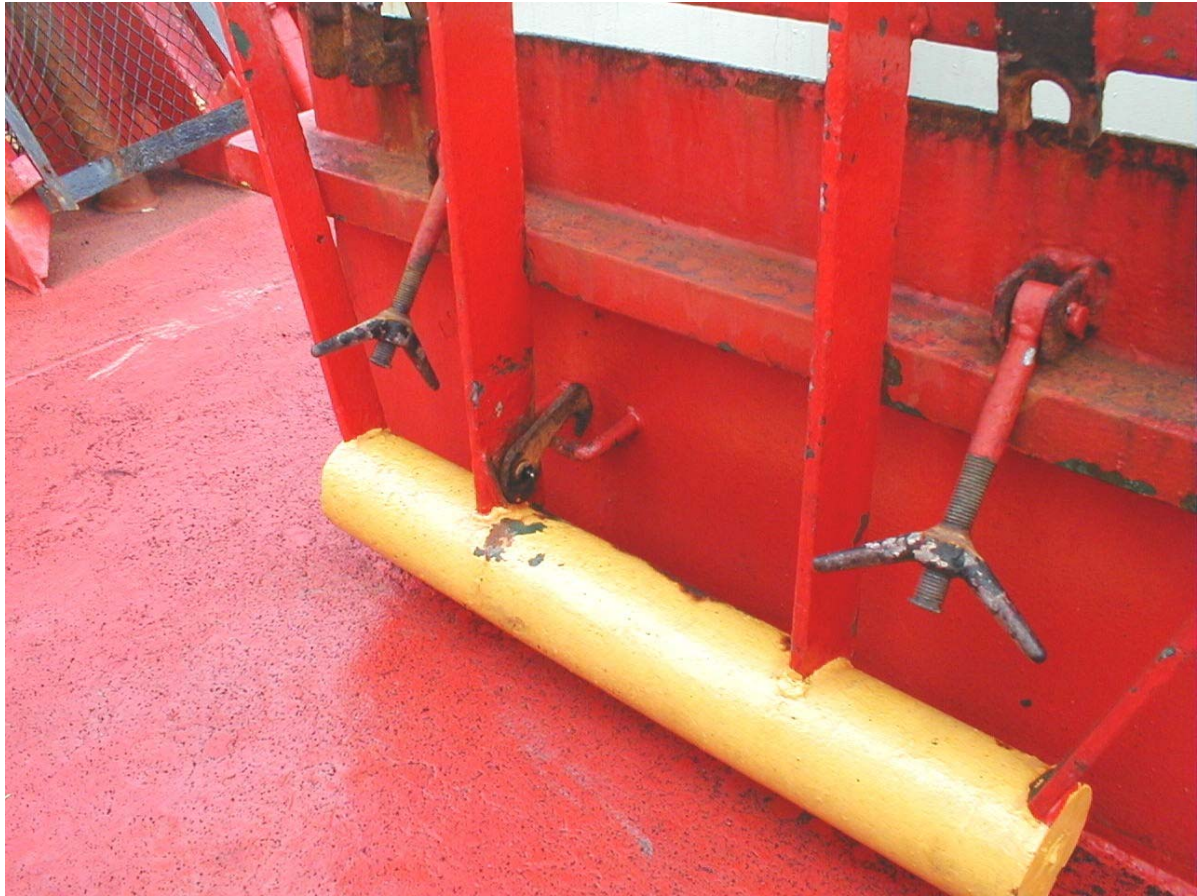
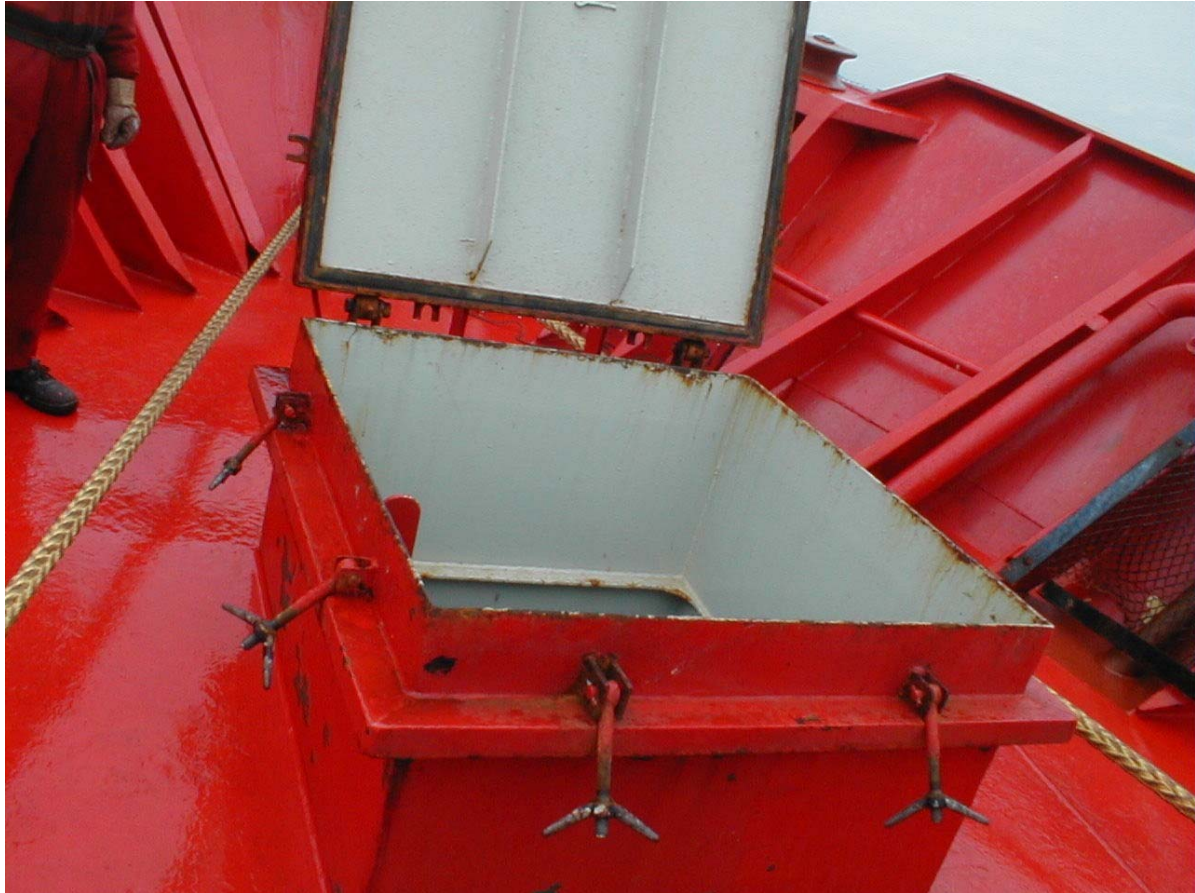
The hatch is made of steel and it measures approximately 120 x 120 cm. It is fitted with 8 fasteners for battening down purposes and with a counter weight to make it easier to open the hatch cover. It is also fitted with a hook to keep the hatch in an open position. When the hatch was open and the hatch cover was standing in an upright position by the counter weight, there would be a small clearance between the hook and its pad eye on the hatch coaming (see picture) to avoid tension on the hook.

The hatch has to be secured in the open position. In this case, the hatch was fitted with a proper hook. It was, however, inexpedient that the hook did not keep the cover sufficiently locked, and thus the movements of the ship and/or the effect from the waves released it.

The clearance between the hook holding the hatch and its pad eye is made at the construction and not by wear and tear.

The accident happened because breaking waves and movements in the ship made the hook of the hatch cover release from its pad eye in the hatch coaming and thus the cover closed while the AB was standing next to the hatch.

On the ship, they have arranged drainage from the room to a cofferdam, which can be emptied by use of a ballast pump. They have also fitted the hatch cover with a small manhole. Furthermore, it has been decided to turn the ship to get the waves in aft when this kind of work is done.
