Division for Investigation of Maritime Accidents - Denmark

Heavy weather damage – VILLUM CLAUSEN – 11 January 2010

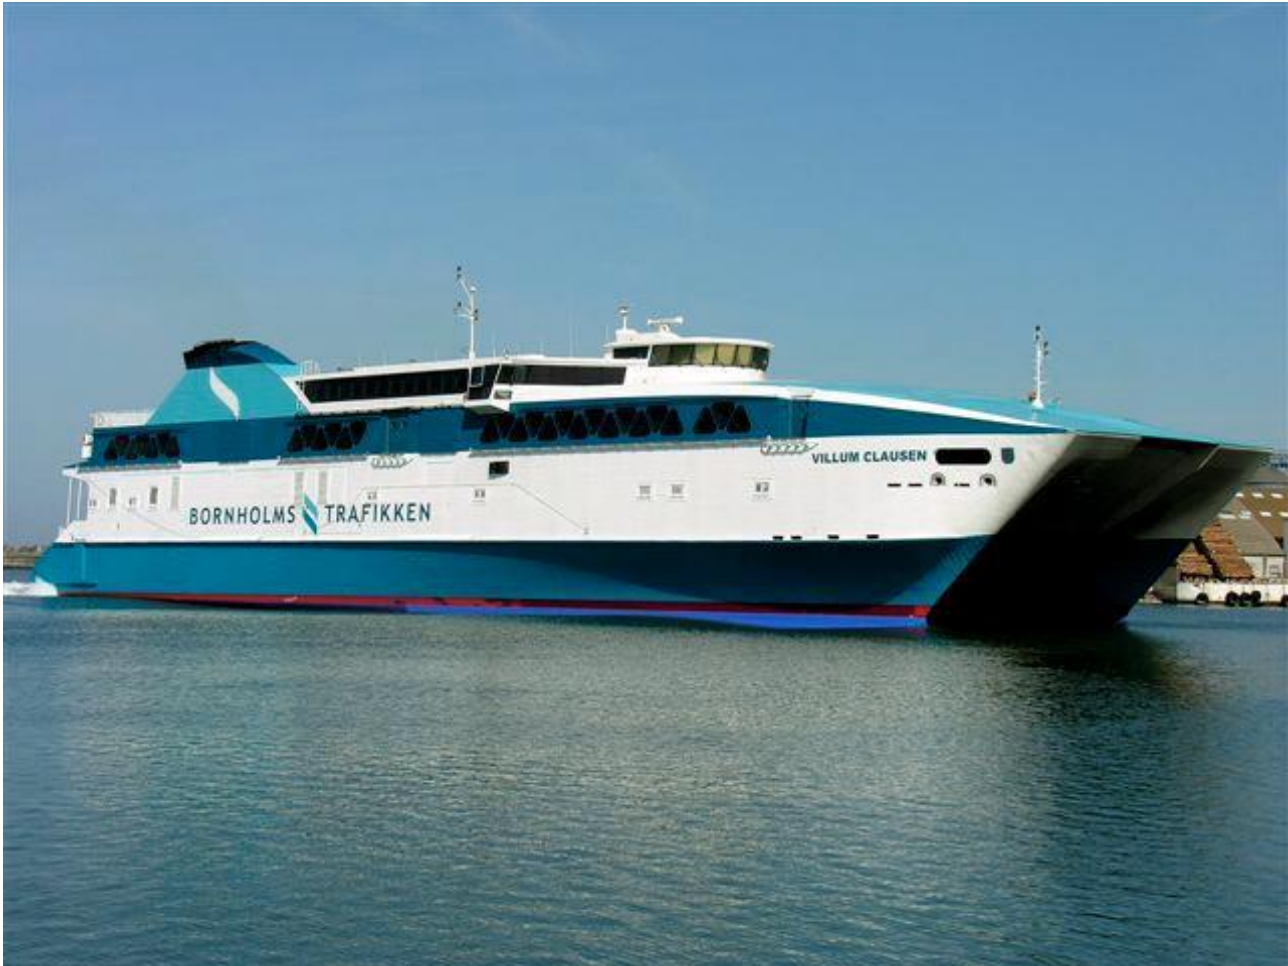
On 11 January 2010, during a crossing from Ystad in Sweden to Rønne on the island of Bornholm, the high-speed craft VILLUM CLAUSEN hit one or more waves with a speed of 33-35 knots. The slamming caused severe indentations in the bow.
