Division for Investigation of Maritime Accidents - Denmark

Accident to seafarer – EGESUND – 20 January 2010

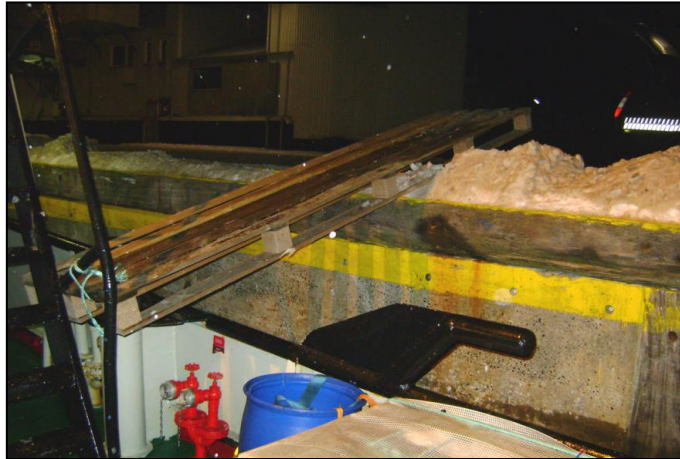
When entering the ship he slipped on a provisional arrangement used as a gangway. The arrangement consisted of a wooden pallet 3 metres long. The chief engineer fell in the gap between the ship and quay.

- An inappropriate arrangement used as gangway.
- Inappropriate use of footwear, wooden shoes.
- The chief engineer's judgment- and reaction capability were reduced due to consumption of alcohol.
- The chief engineers overweight restrained his freedom of movement and made his rescue difficult.
- There were no satisfactory procedures describing to access to the ship.
- There was not sufficient equipment on board to ensure safe access to the ship.

1. That the owner ensures means to safe access to the ship under all circumstances.
2. A revision of the ships Safe Management System.
