Report from the Division for Investigation of Maritime Accidents

## **Container ship SORØ MÆRSK Accident to seafarer, engineer scalded by steam and hot water 4 November 2008**

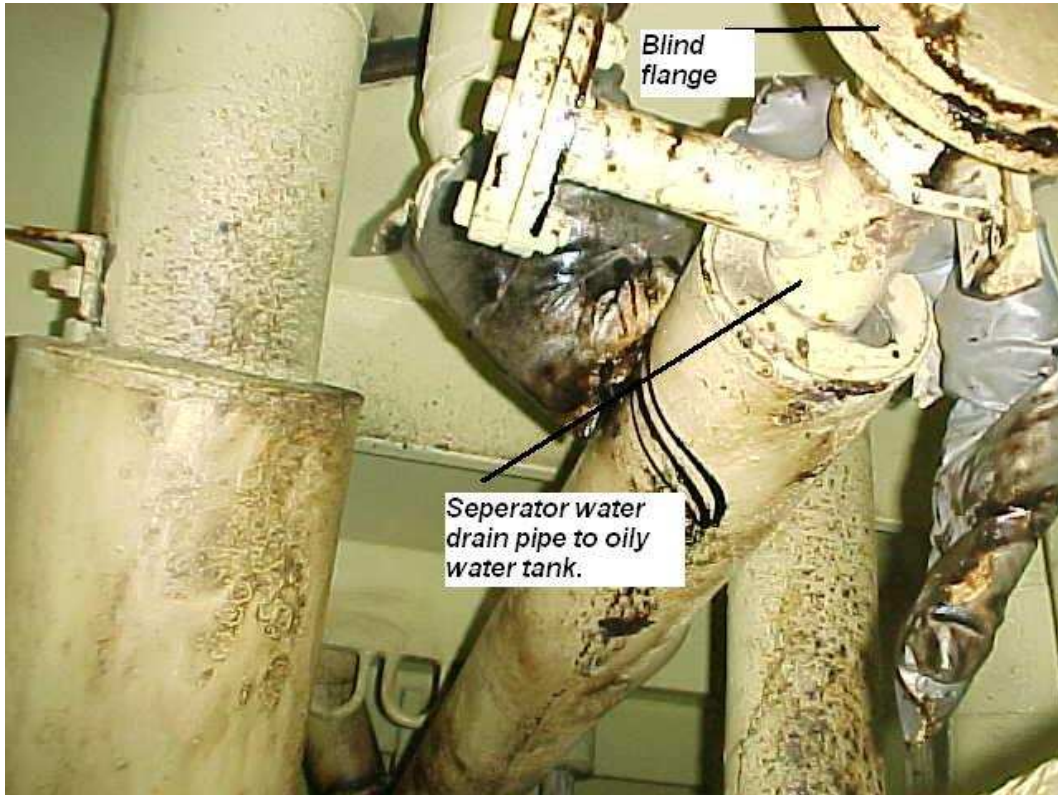
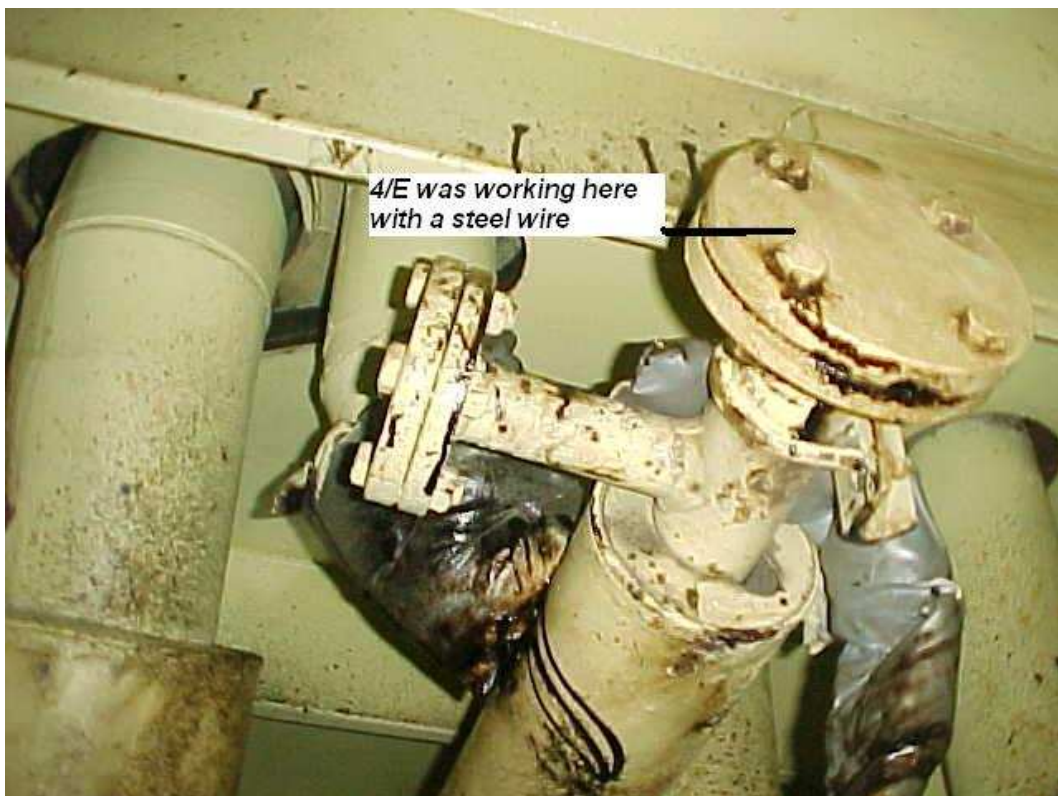
He tracked the drain pipe and found a visiting flange (blind flange) right under the ceiling in the generator room situated under the fuel oil separator room.

After that, he was able to dismantle completely the flange. I took a look inside the flange and saw that the pipe was almost 90 % clogged from its diameter (the pipe is horizontal in that position – generator room).

After maximum 10 seconds, the sludge inside burst out and hit the engineer all over. It was between 1300 and 1330.

The 4<sup>th</sup> engineer was hit and scalded by steam, hot water and oil streaming out from the pipe after manipulating an obstruction in the pipe with a wire.

A steam pressure had obviously been building up in the pipe.

It seems like there were two obstructions in the drain pipe, and in the confined space between the obstructions water and oil was heated by the steam tracing, thus creating steam pressure.

*A safety sign has been made and placed in the accident area.*
