Report from the Division for Investigation of Maritime Accidents.

## Report regarding the collision between the fishingvessel **SIMONE** and the containership **AURORA** in the Sound on 29 October 2009.

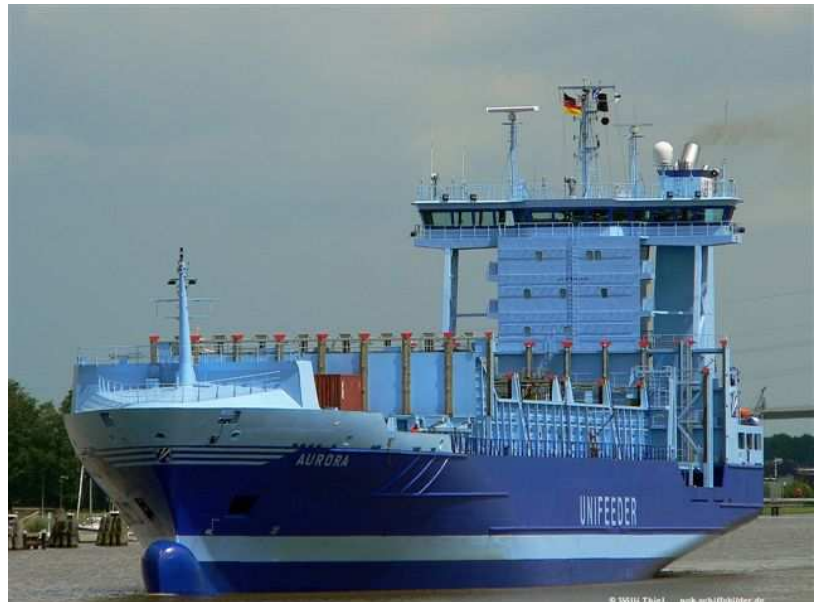
AURORA (Foto: [www.shipspotting.com](http://www.shipspotting.com) / Willi Thiel)

The master of AURORA reported the collision on VHF to VTS SOUND, and received orders to anchor on Copenhagen Roads. The vessel anchored at 06.45. Following the collision, AURORA's classification society made an inspection of the vessel, but found no damages.
