Marine Accident Report

DUCHESS of
SCANDINAVIA
Occupational accident
on 11 August 2005

The casualty report has been issued on 17 February 2006

Case: 200508990

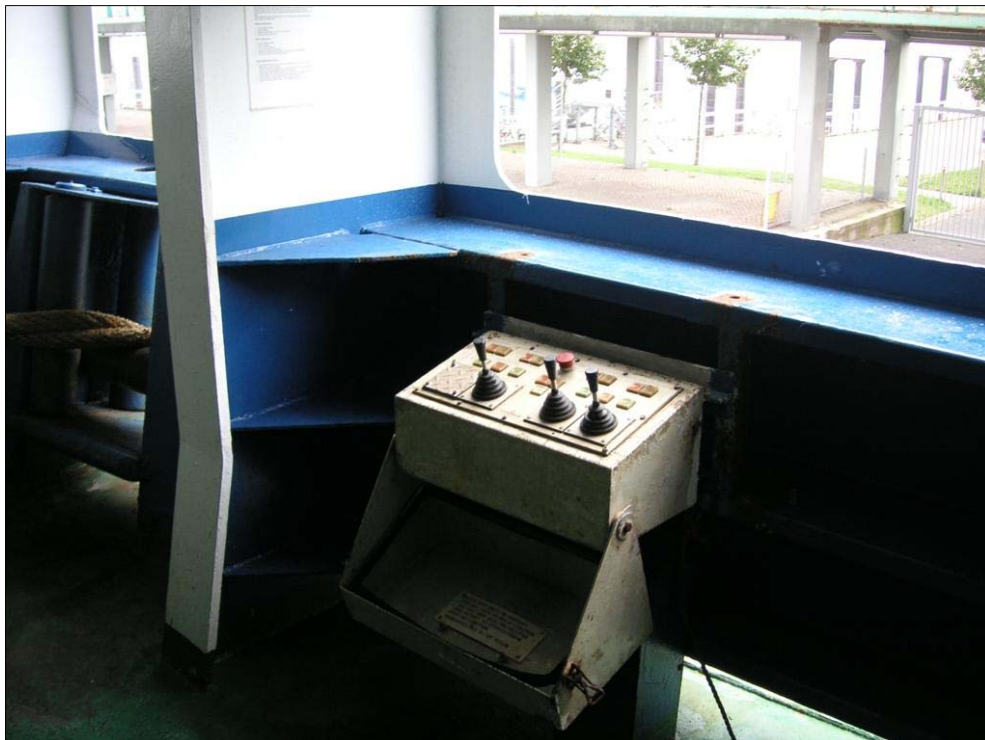
Photo taken on 14 September 2005

After approximately 5 minutes with no use of the winch control, the connection between the winch and the winch control are shut down automatically. By pushing the button below and to the left of the red emergency stop, the contact is re-established. By pushing the button close to emergency stop, the winch's rate of rotation will be reduced by 50%

The switch to the outer right is only used during service of the unit.
