## Division for Investigation of Maritime Accidents - Denmark

### Occupational accident on ESVAGT GAMMA on 15 February 2008

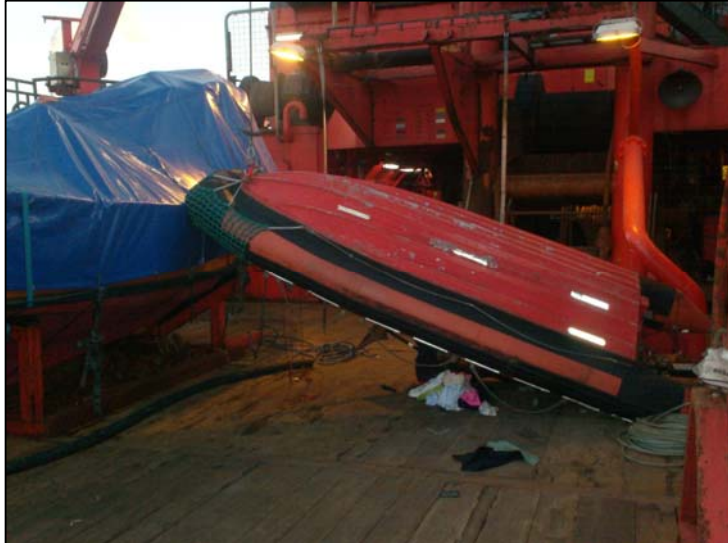
After being a shore for maintenance ESVAGT GAMMA's MOB-boat returned to the ship and placed in its foundation by another crane than the one normally operating the boat. Later the same day a ship's assistance was asked to lash/secure the boat. While working in the boat it overbalanced and fell to the deck.

- On the evening of the accident the master gathered the crew and informed about the accident.
- A Work Risk Assessment has been elaborated and implemented for work in the MOB-boat when it rest in its foundation.
- ESVAGT A/S is changing the foundation of the MOB-boat to ensure the stability of the boat when the lifting wire is not fastened.
- ESVAGT A/S has been examining all other ships in its fleet to prevent similar accidents.
- ESVAGT A/S has informed all ships about mandatory use of personal safeguarding when working in MOB-boats if they are placed more than then 2 meters above deck.
